MEMORANDUM ON
X 64 80705 #
Code SA
MERCURY-REDSTONE BOOSTER PROBLEMS

(NASA TM X-54664)

NASA - Space Task Group
Langley Field, Virginia
March 20, 1961

Subject: Mercury-Redstone booster problems

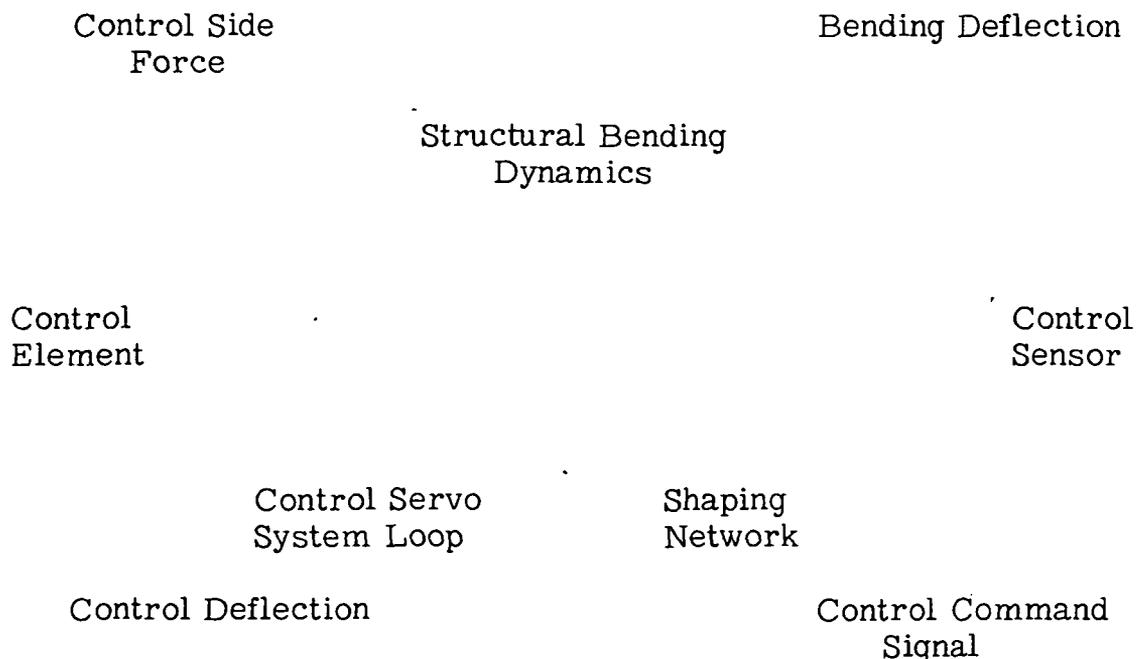
(a) Rudder and carbon vane vibration. - The control system picked up oscillations near the second bending mode natural frequency of the booster on flight MR-1A which resulted in a sustained vibration

MSFC has referred to this phenomenon as a "structural feedback loop", and in block diagram form appears as follows:

To eliminate this problem of structural feedback, filters have been added to the shaping network which reduce gains at the second mode bending frequency which effectively damp the system.

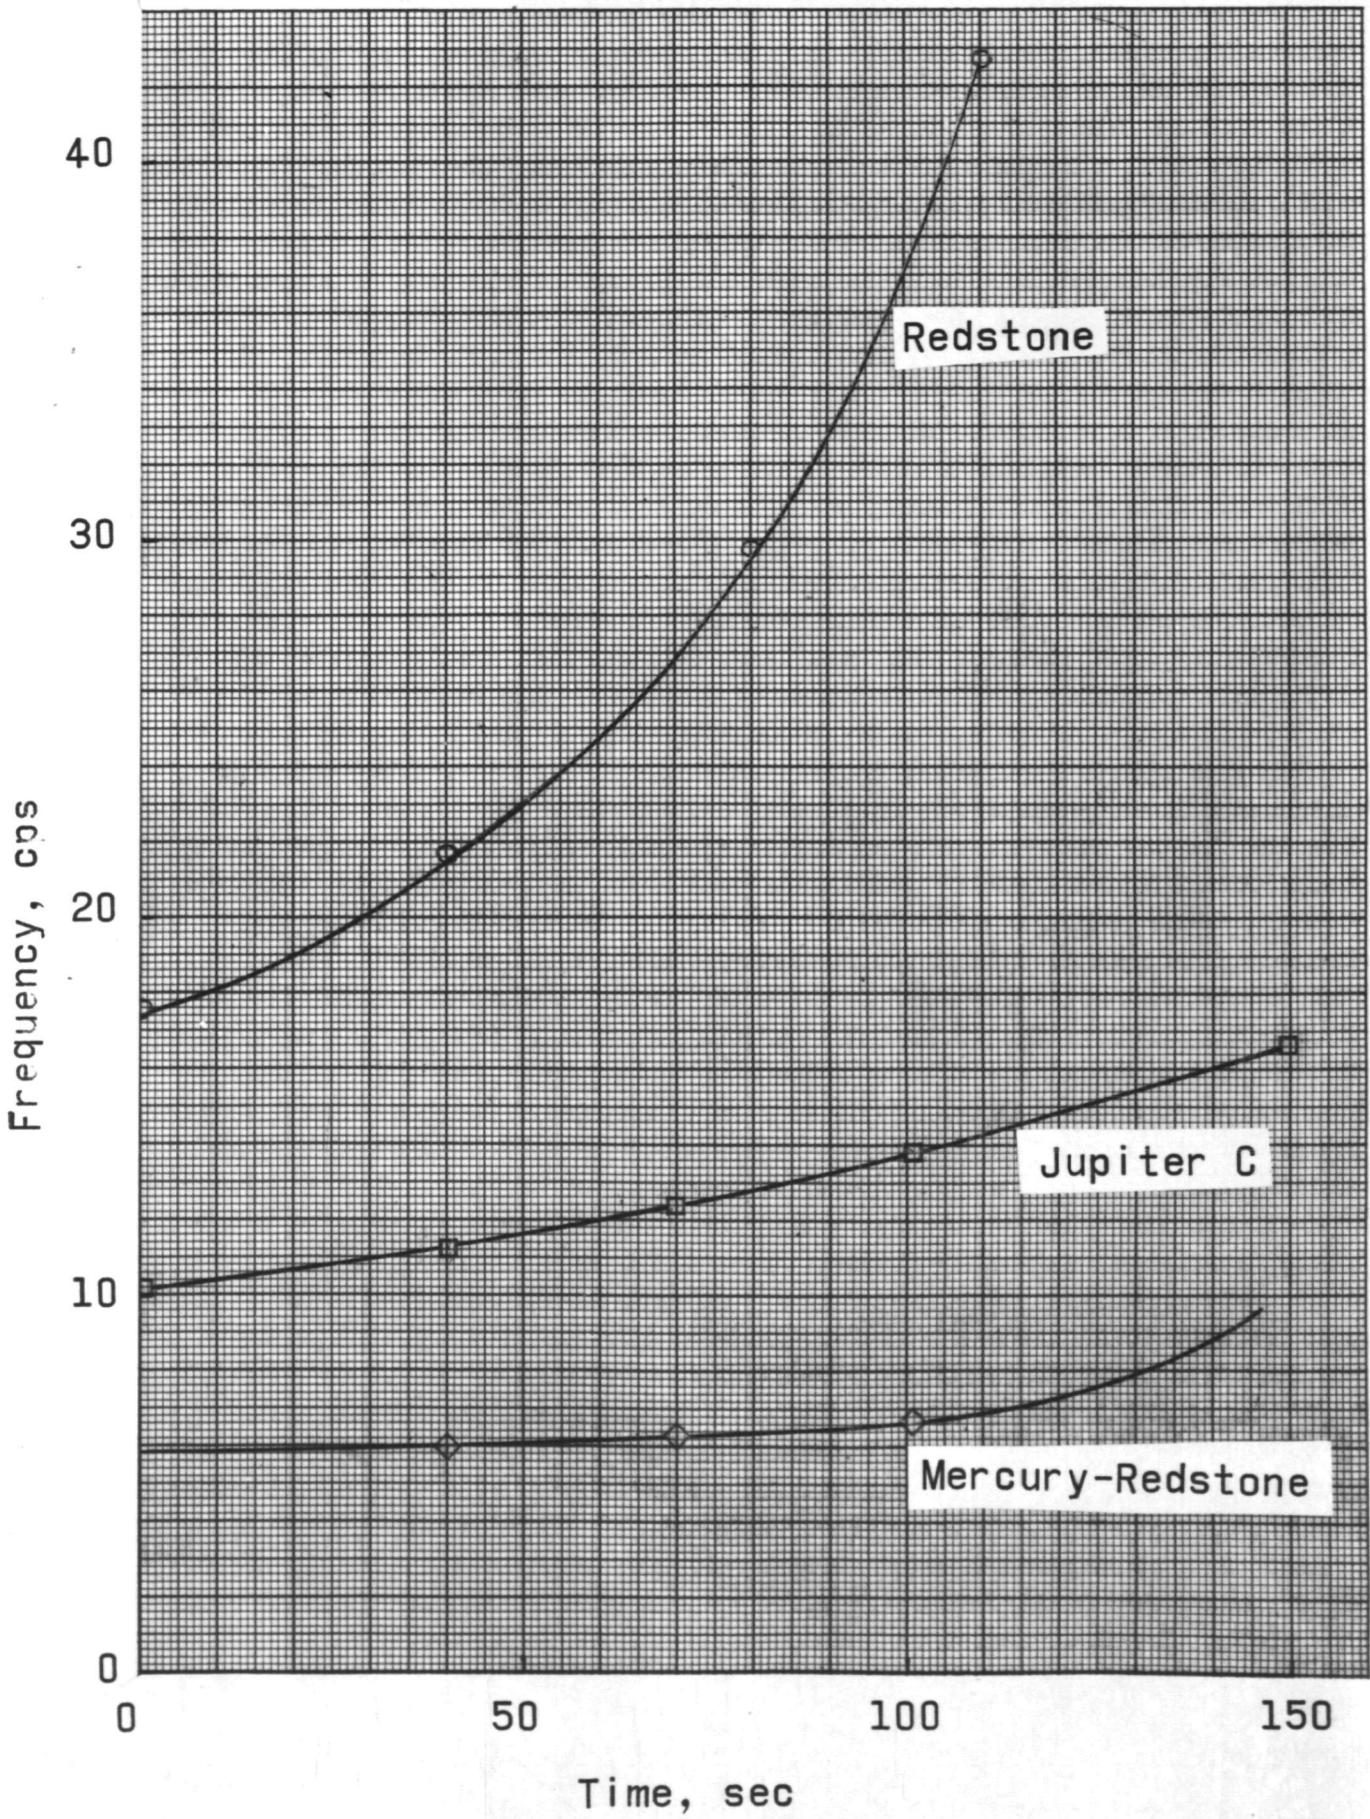
Figure 1.- Second order bending frequency comparison.

This problem was caused by the lowered second bending frequency of the Mercury-Redstone booster-capsule combination. Figure 1 shows a comparison of second bending frequencies of a conventional Redstone missile, Jupiter C configuration, and the Mercury-Redstone booster-capsule combination. As can be seen, the normal 20-45 normal second bending frequency of the Redstone has been reduced to 6-9 cps. Control oscillations were more pronounced late in flight where the second mode natural frequency is around 9 cps.

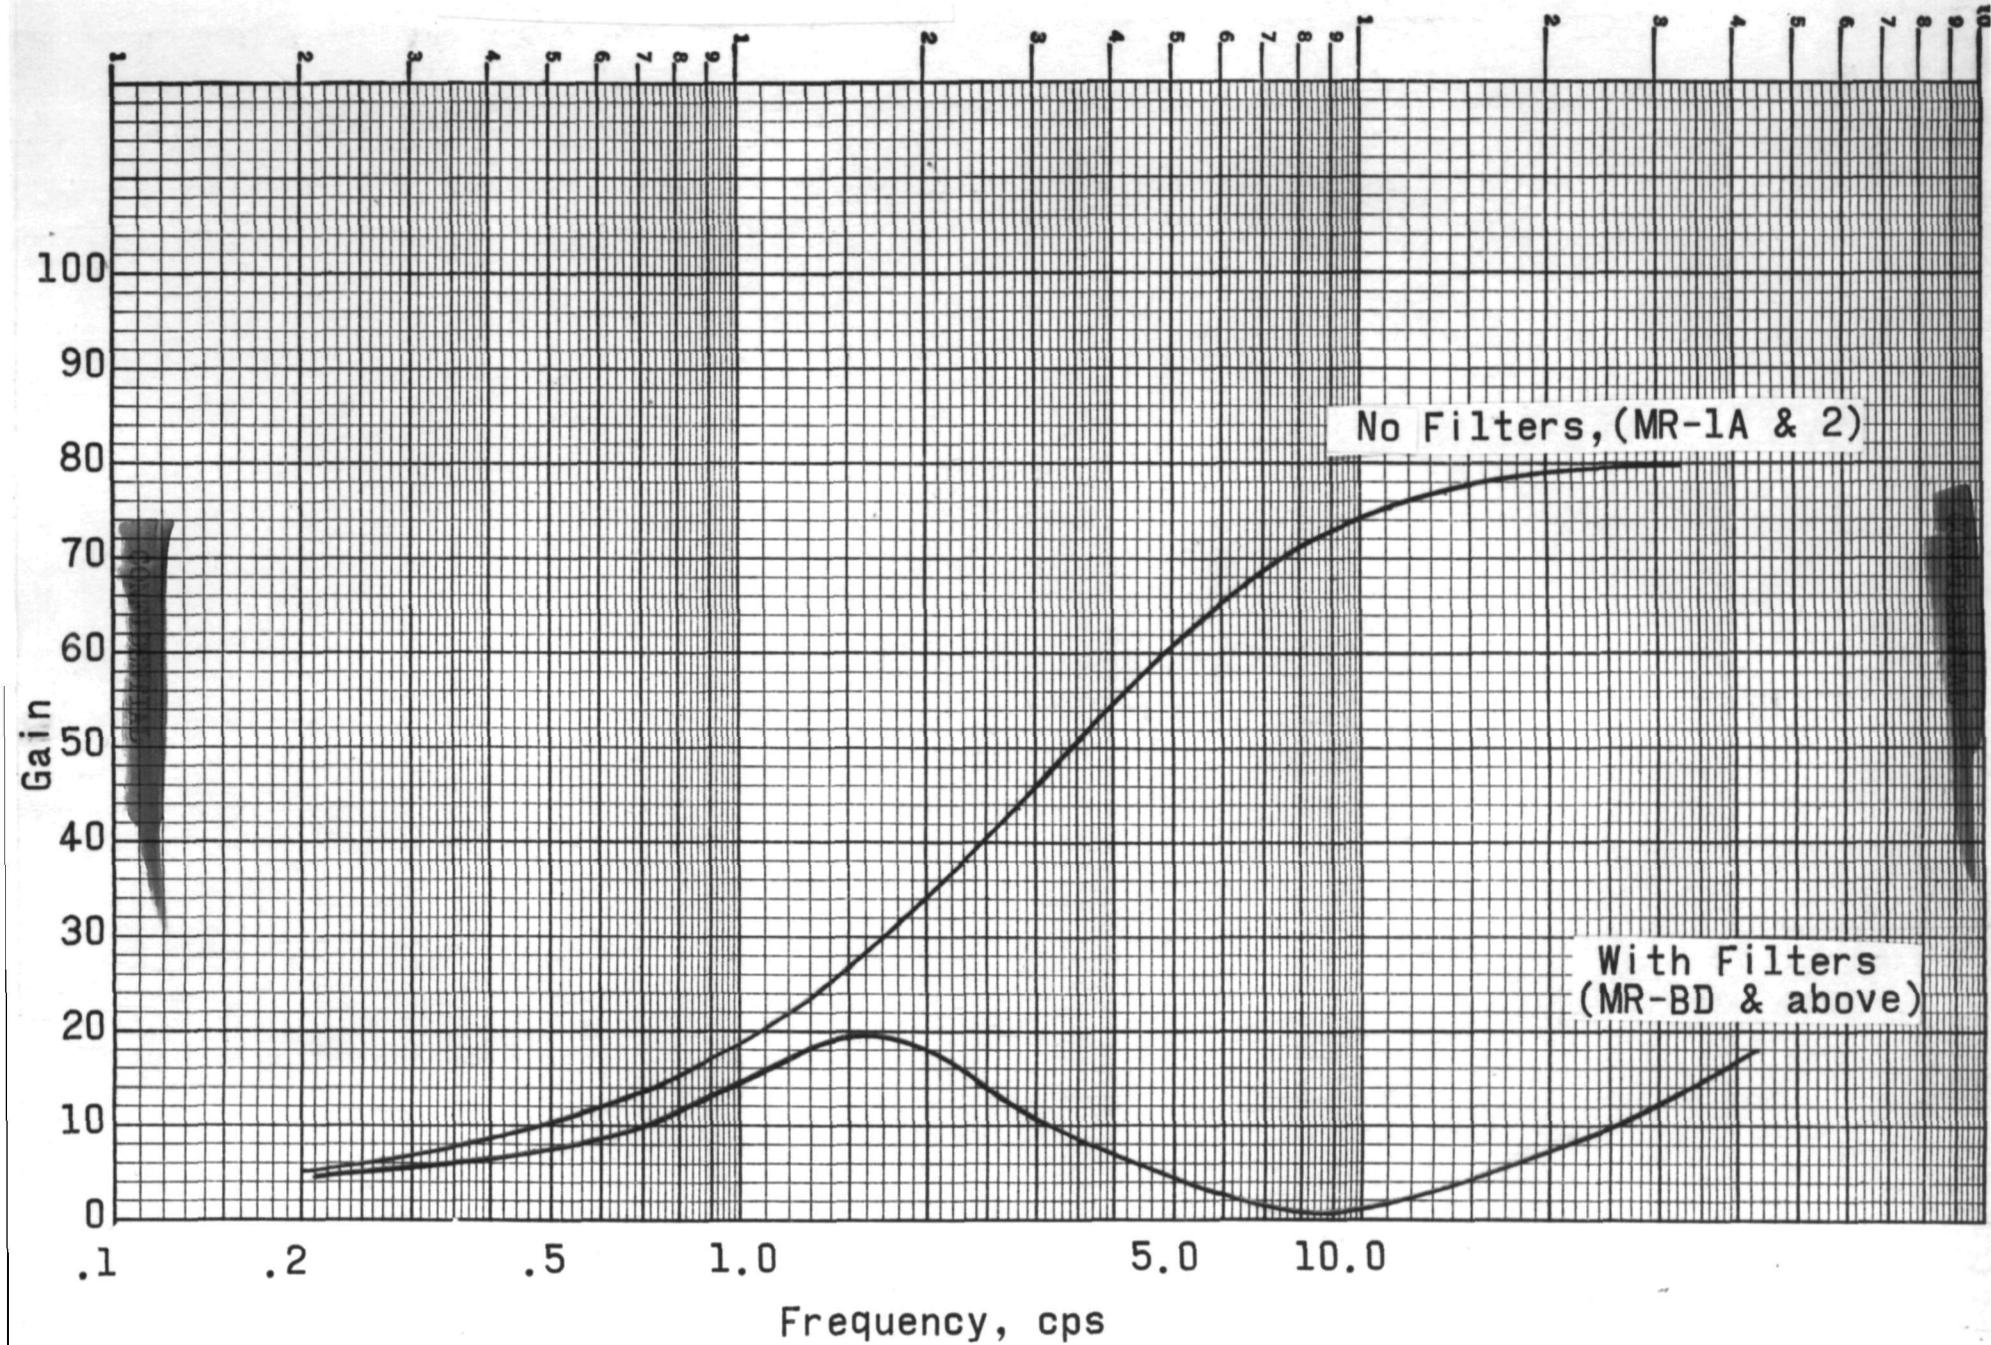
Figure 2.- Control system gain with and without filters.

Analog studies show the gain to be reduced as shown in figure 2. As can be seen in the figure, the gain has been reduced by a factor of approximately 30 at 9 cps. To a lesser extent, the gain at the first mode bending frequency (3.3 cps) has also been reduced.

The writer inspected the analog test setup which includes the control servo system loop hardware, the control sensor (LEV-3) and booster tail section. Several runs were made for his observation with and without the filtering network. The results were satisfactory and conformed to gain reductions as outlined. Records of typical runs were brought back to the Space Task Group.

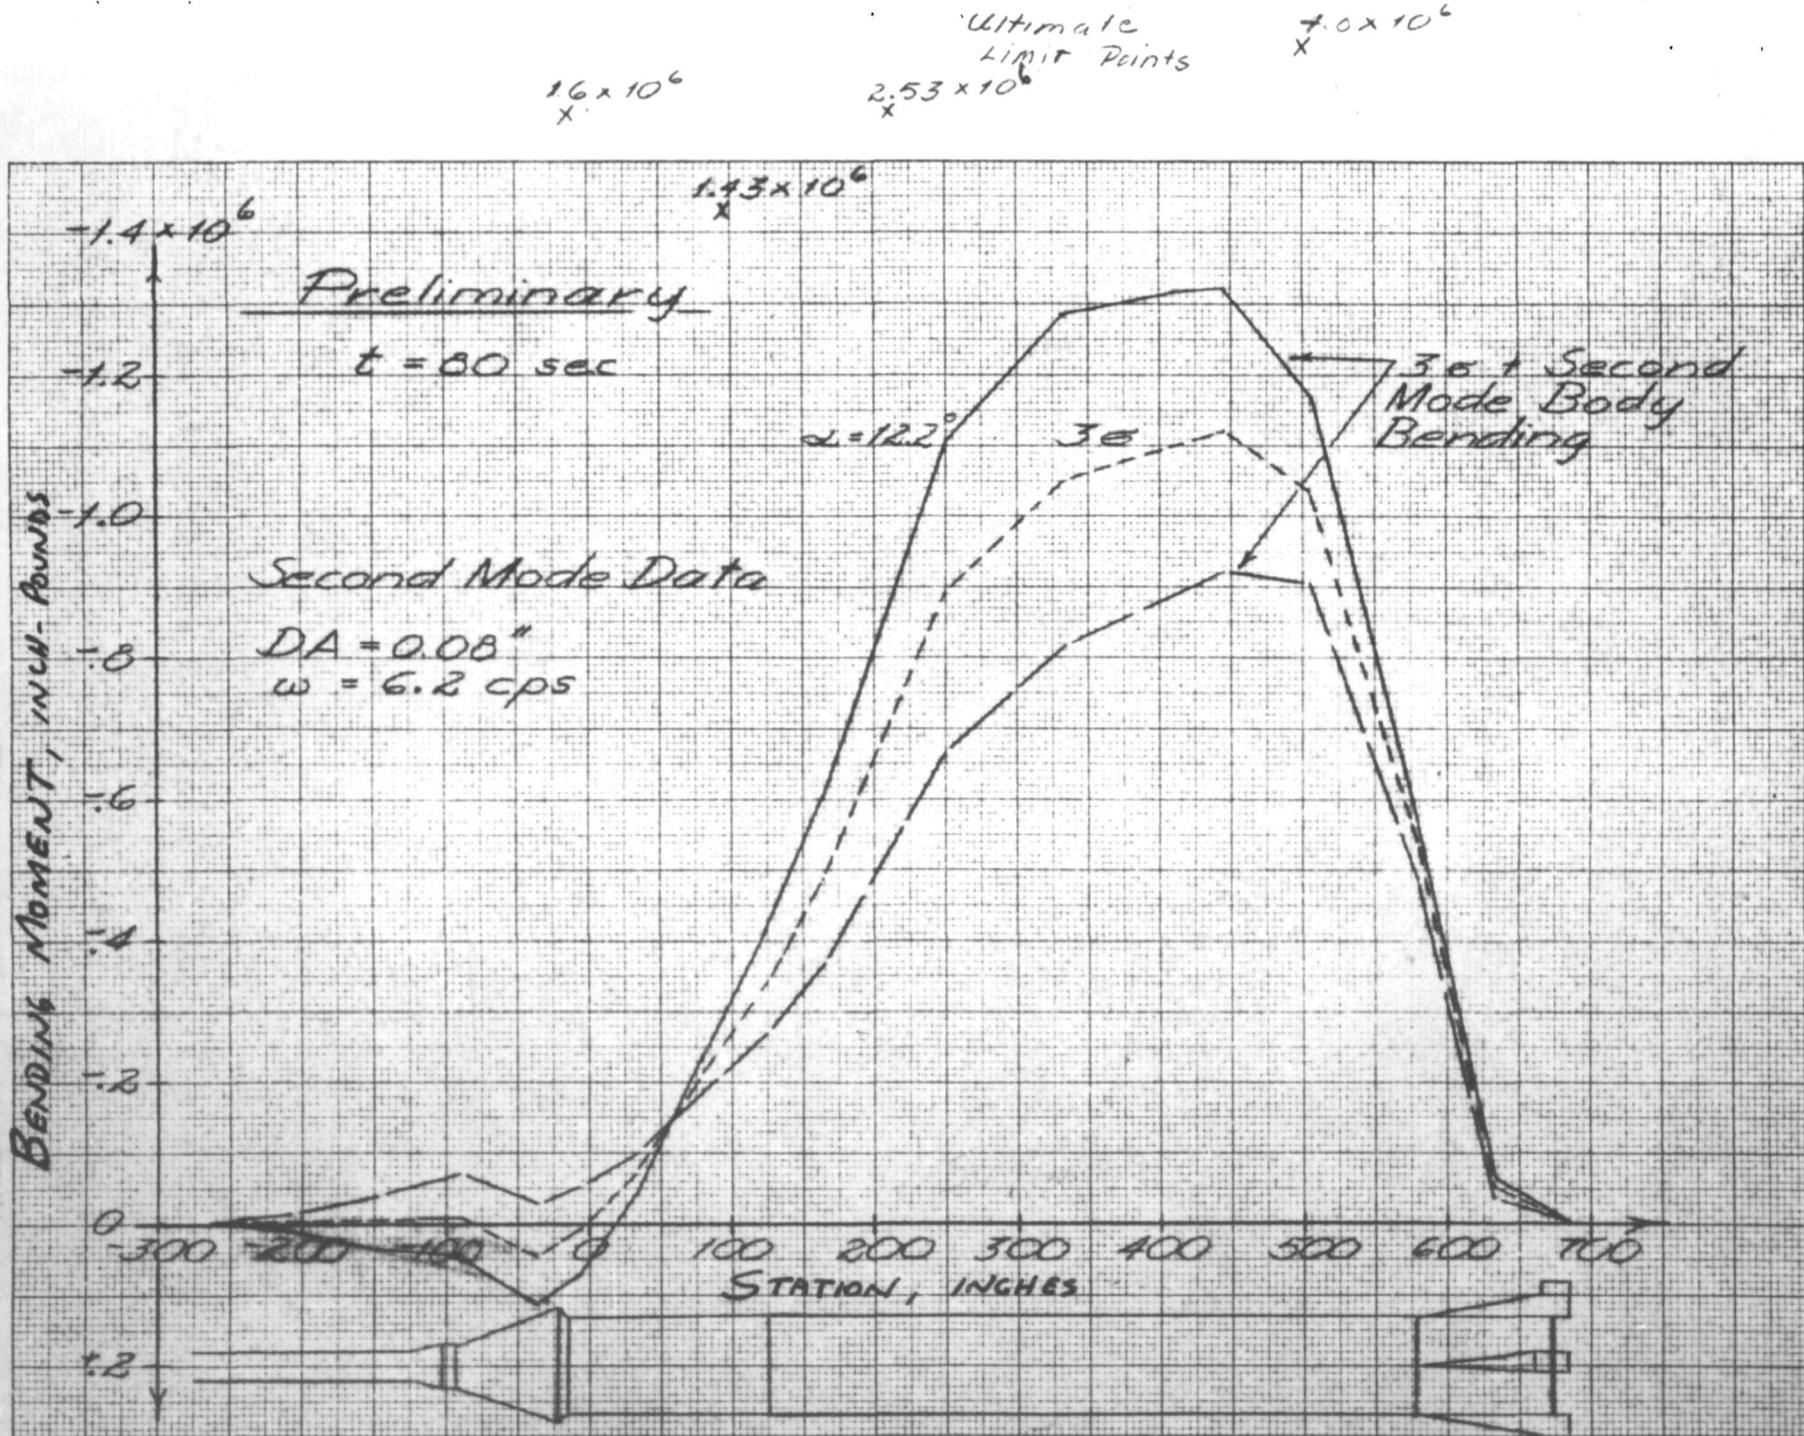
Figure 3.- Second mode bending data at $t = 80 \text{ sec.}$ ($\sim \text{Max } q$)

An inquiry was made as to the structural loading due to the structural oscillations. Figure 3 shows the bending moment plotted versus vehicle station. As can be seen, the bending moments produced are considerably less than ultimate limit points. Thus, it can be concluded that no structural problem exists due to this oscillation.

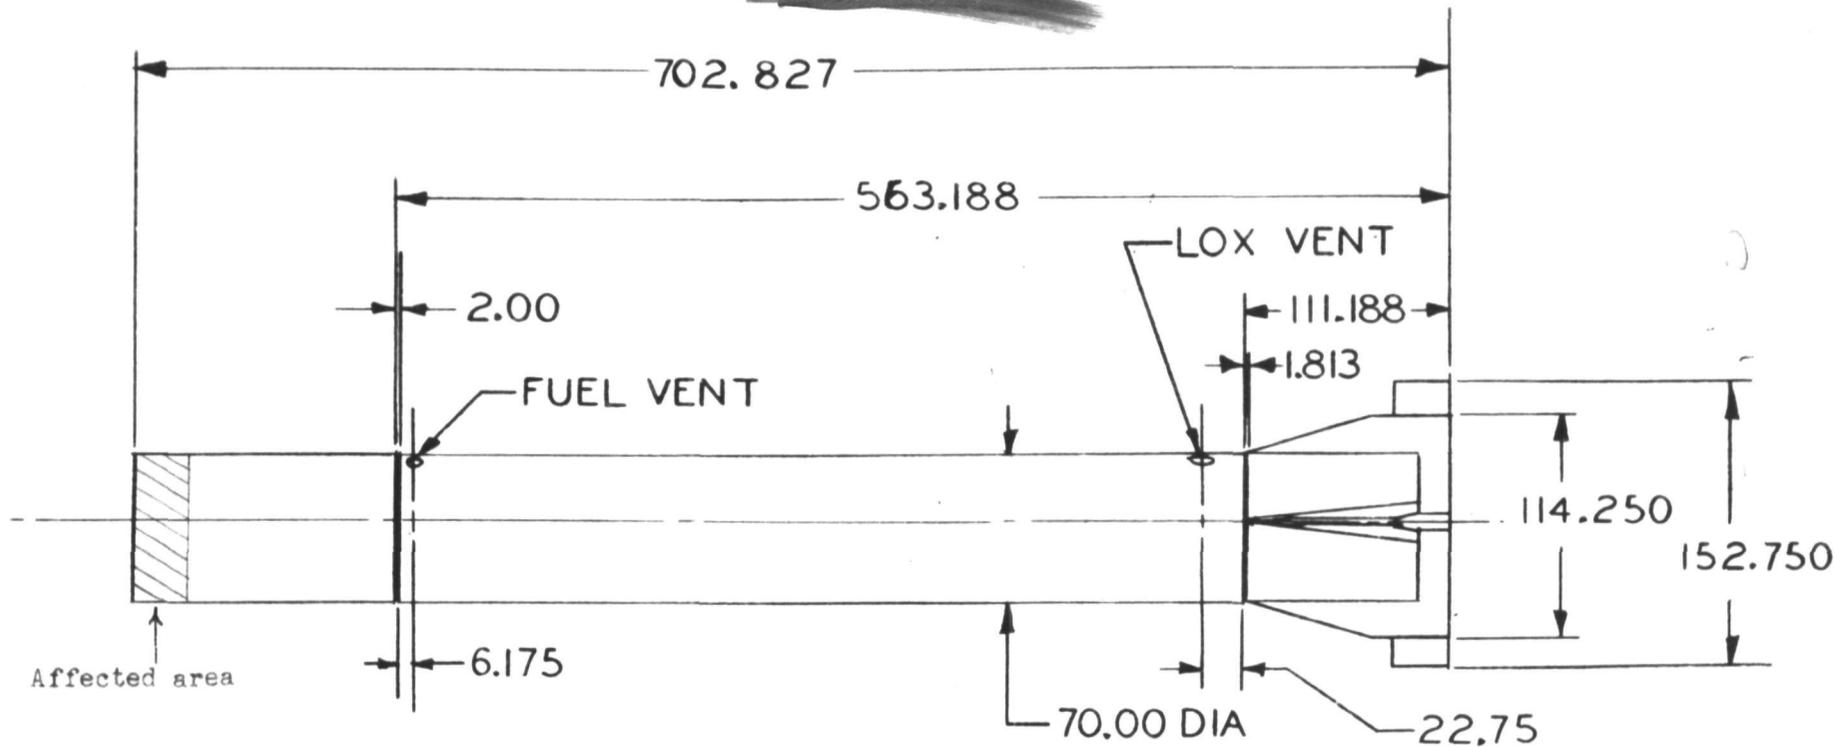
(b) Instrumentation compartment vibration. - High frequency vibration in the area of the instrumentation compartment of the booster occurred on Mercury-Redstone flights MR-1A and MR-2. The nature of the vibration indicates that it is aerodynamically excited and probably is due to the lower capsule clamp ring. Vibration level in this area for a standard Redstone booster is $\pm 1g$ maximum. On MR-2 flight it was greater than $\pm 6g$ maximum. Instrumentation was limited to $\pm 6g$ so that the amount over $\pm 6g$ is not known.

Figure 4.- Area of booster to where dampening material has been applied.

An attempt to damp this vibration will be made on the Mercury-Redstone booster test flight. An "undercoat" type of material has been applied to the upper part of the instrumentation compartment as shown in figure 4. The material is a mesh with lead filings and ground asbestos with a resinous filler. It is about 1/4-inch thick. Around 210 pounds of the material has been applied. It is expected that this material will effectively damp the vibration. However, the pickups will be calibrated to $\pm 12g$ on the MR-BD flight so that if the vibration level remains the same as on MR-2, the system will be capable of measurement.

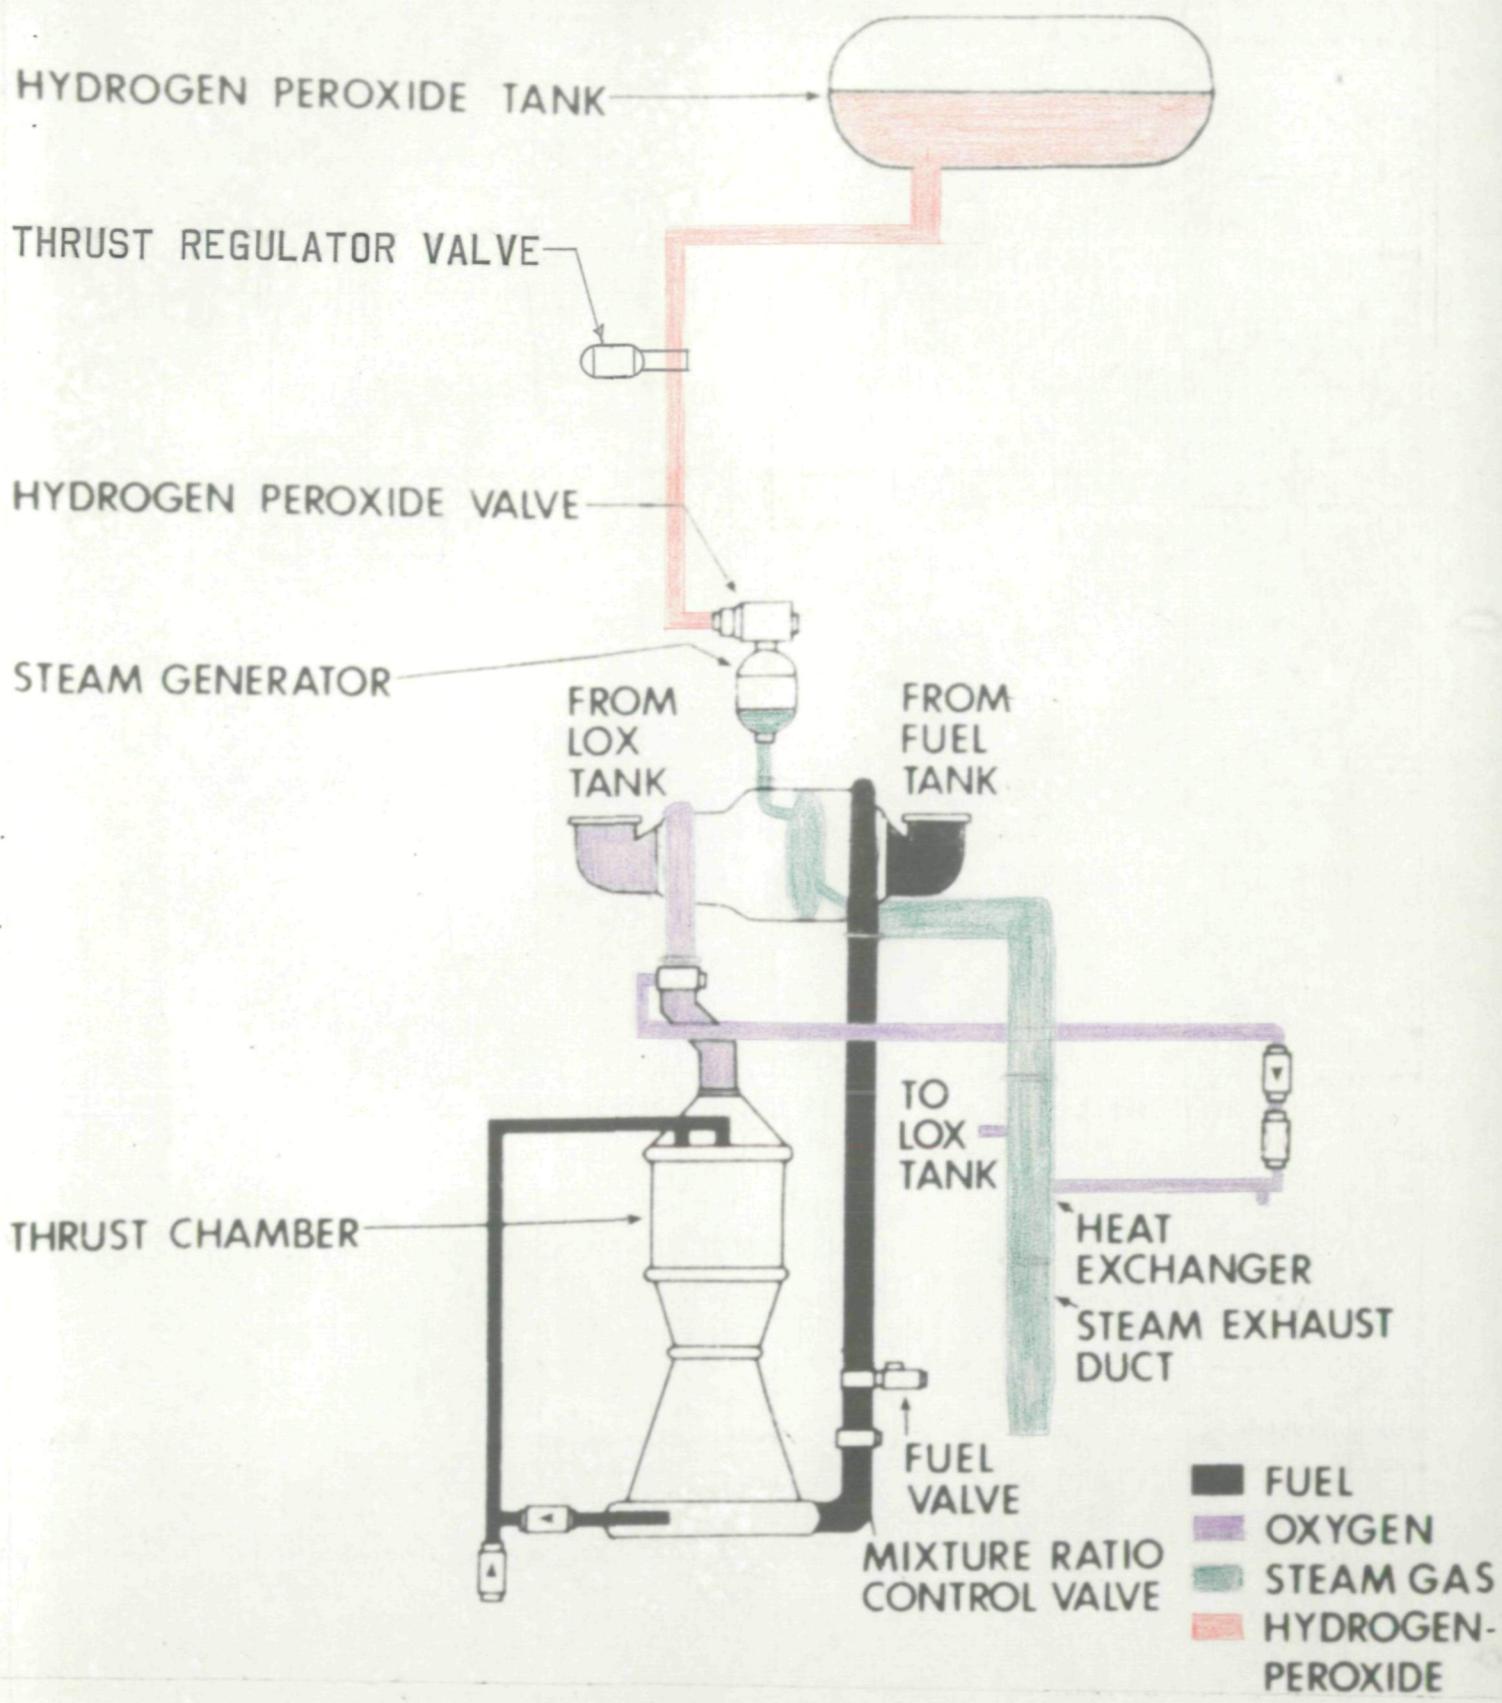
Figure 5.- A7 engine flow schematic.

(c) Thrust controller. - MR-2 flew with the servo control valve wide open. This allowed full flow of H_2O_2 to the steam generator with consequent greater than normal propellant flow. An engine flow

schematic is shown in figure 5. Figure 6 shows a plot of control valve blade position versus time. Also plotted on the figure for comparison is the curve for the normal MR-1A flight. As can be seen from the figure, the control valve blade stayed at its full open position of 45° throughout the flight except for three attempts to correct. Early in the flight an attempt at correction was made at around 32 seconds and again at 125 seconds and 132 seconds. This thrust controller malfunction caused greater than normal burning rate which resulted in premature fuel depletion and abort signal generation.

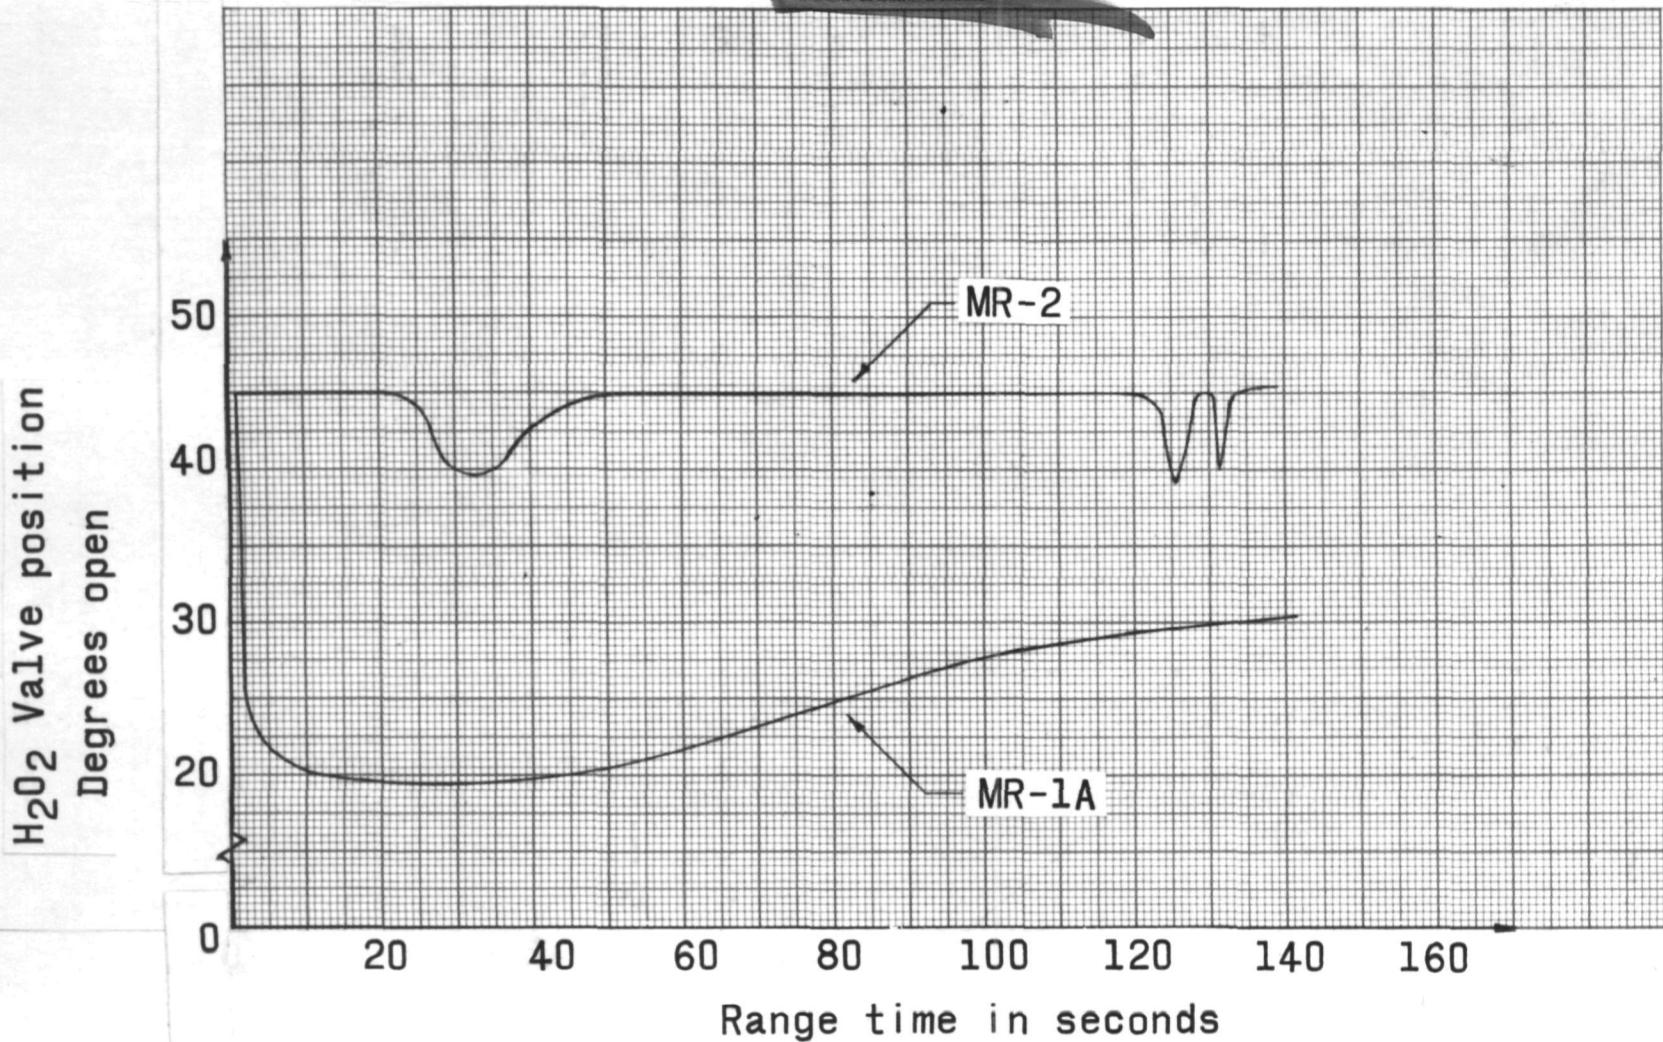
Figure 6.- Hydrogen peroxide valve position vs range time.

None of these reasons can be proved conclusively, and in fact, inspection of figure 6 appears to rule out both (1) and (2) because of the three attempts at thrust correction. A continuing study of the cause for malfunction is underway both at MSFC and by an outside contractor.

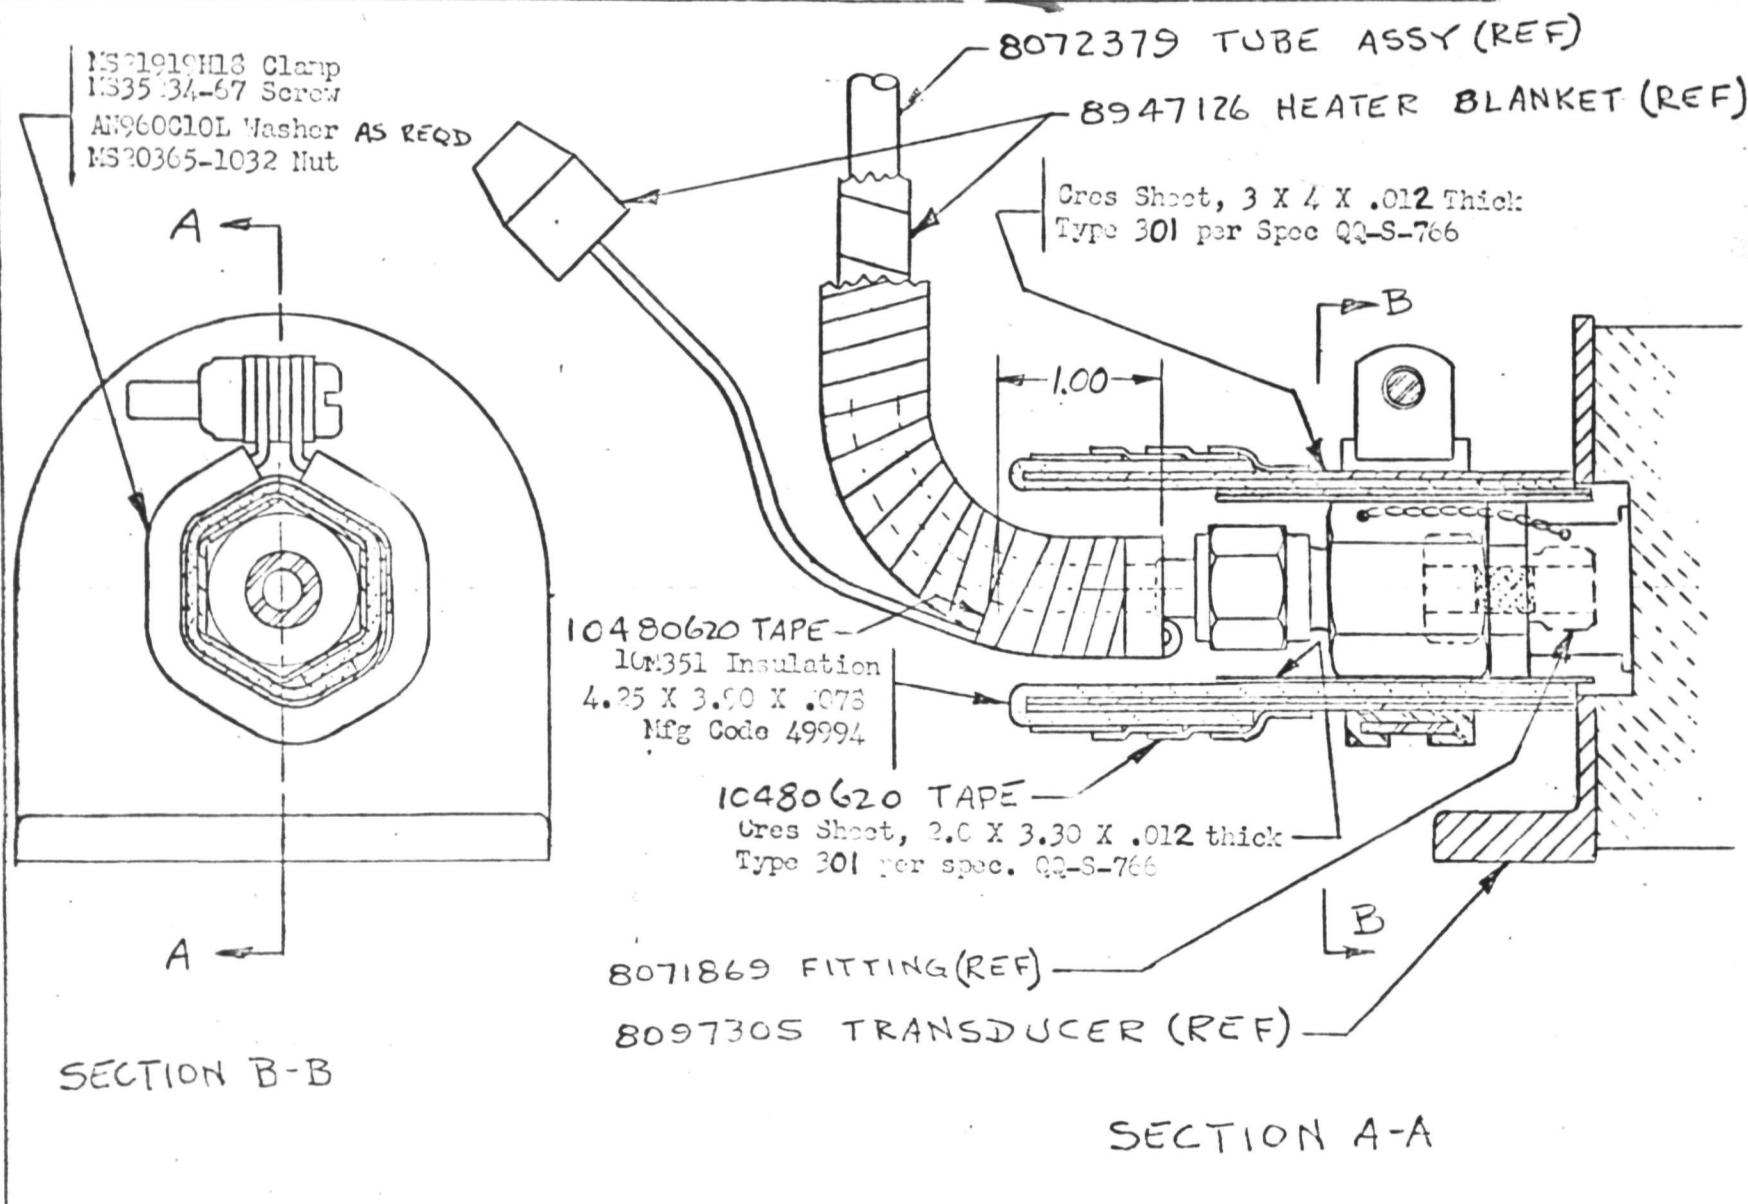
Figure 7.- Shield to prevent icing of transducer surge suppressor fitting.

- (1) Install shield on computer assembly and transducer (Fig. 7)
 - (2) Verify that the surge suppressor is dry
 - (3) Insulate surge suppressor and bushing
 - (4) Cover holes on computer assembly and transducer and transducer mounting plate with tape
 - (5) Tape computer assembly base and chassis
-

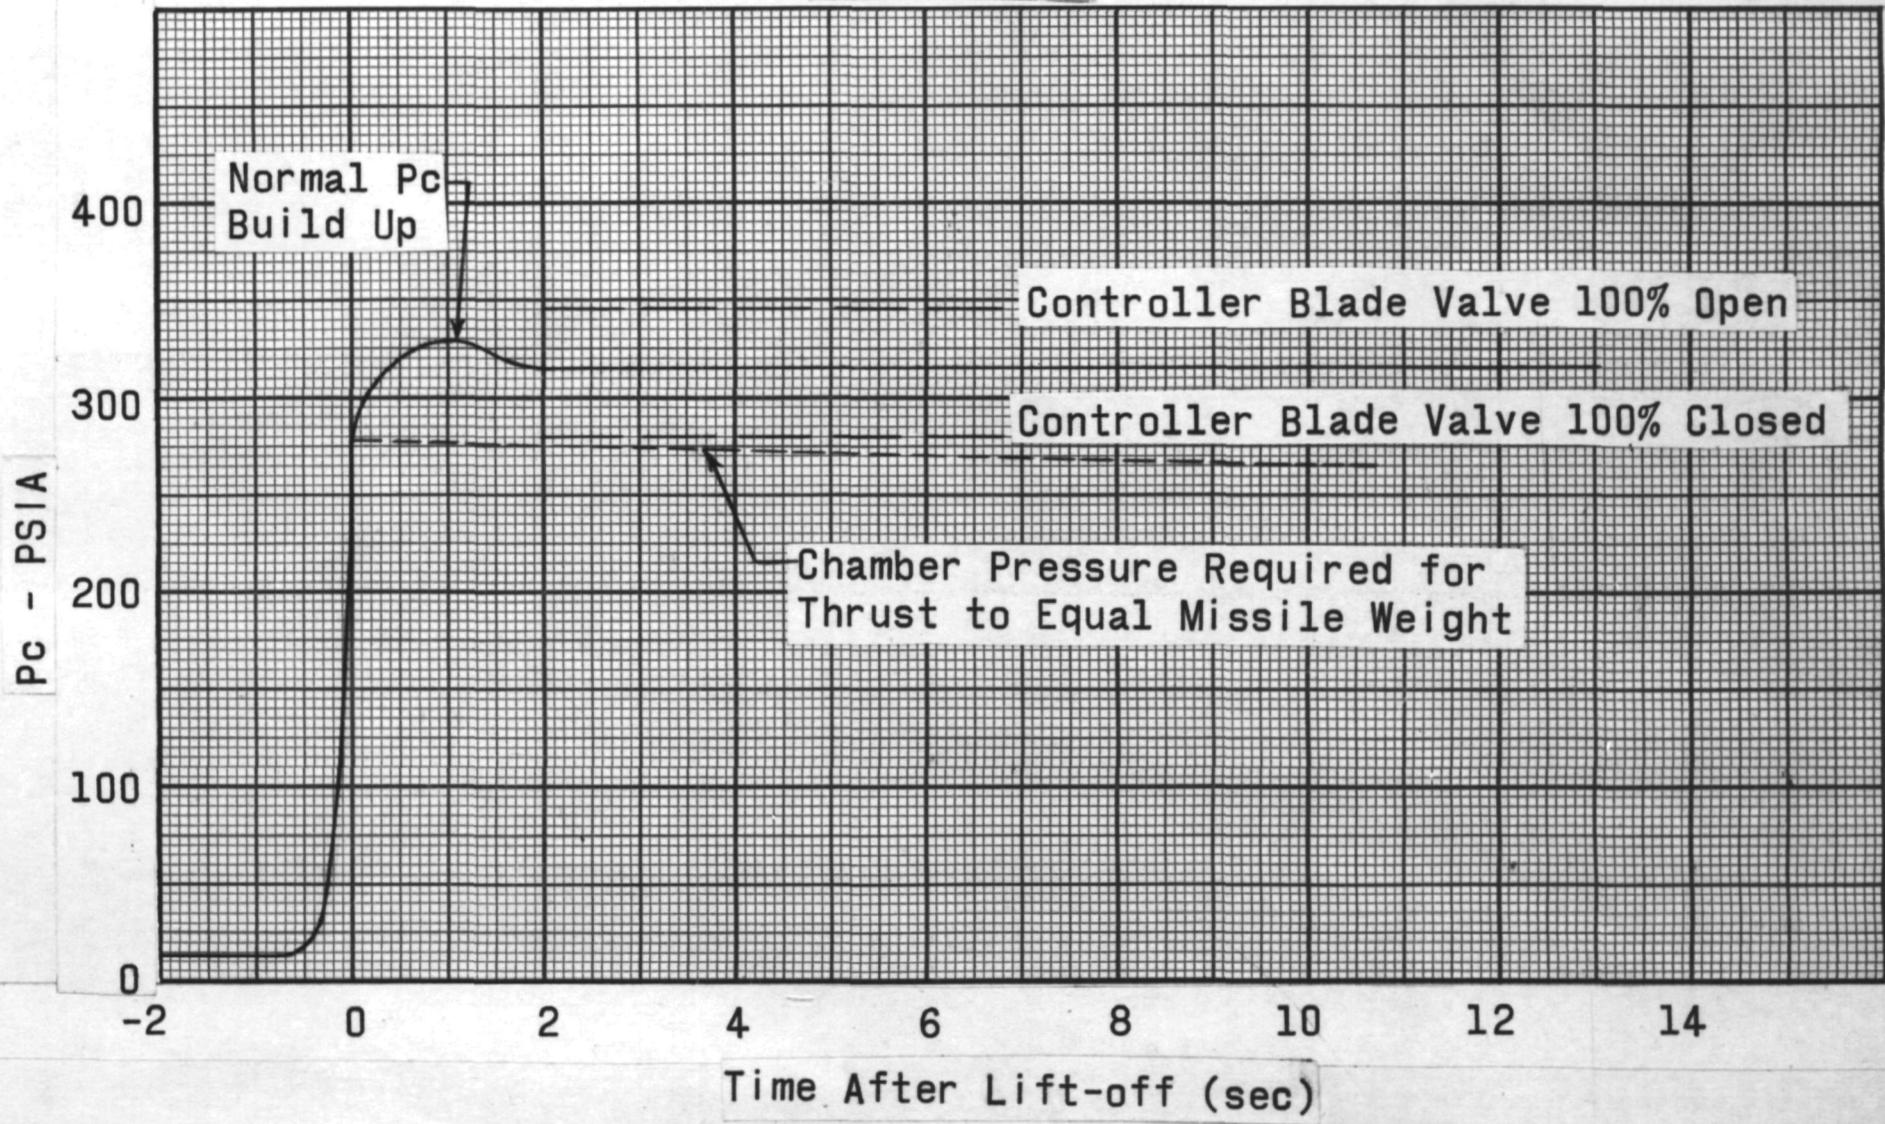
Figure 8.- Required and possible chamber pressures versus flight time for MERCURY Redstone.

Figure 8 shows the variation of thrust chamber pressure with time during the launch phase. It can be seen that even with the control valve blade closed there is adequate thrust for lift-off. However, item no. 8 improves this margin.

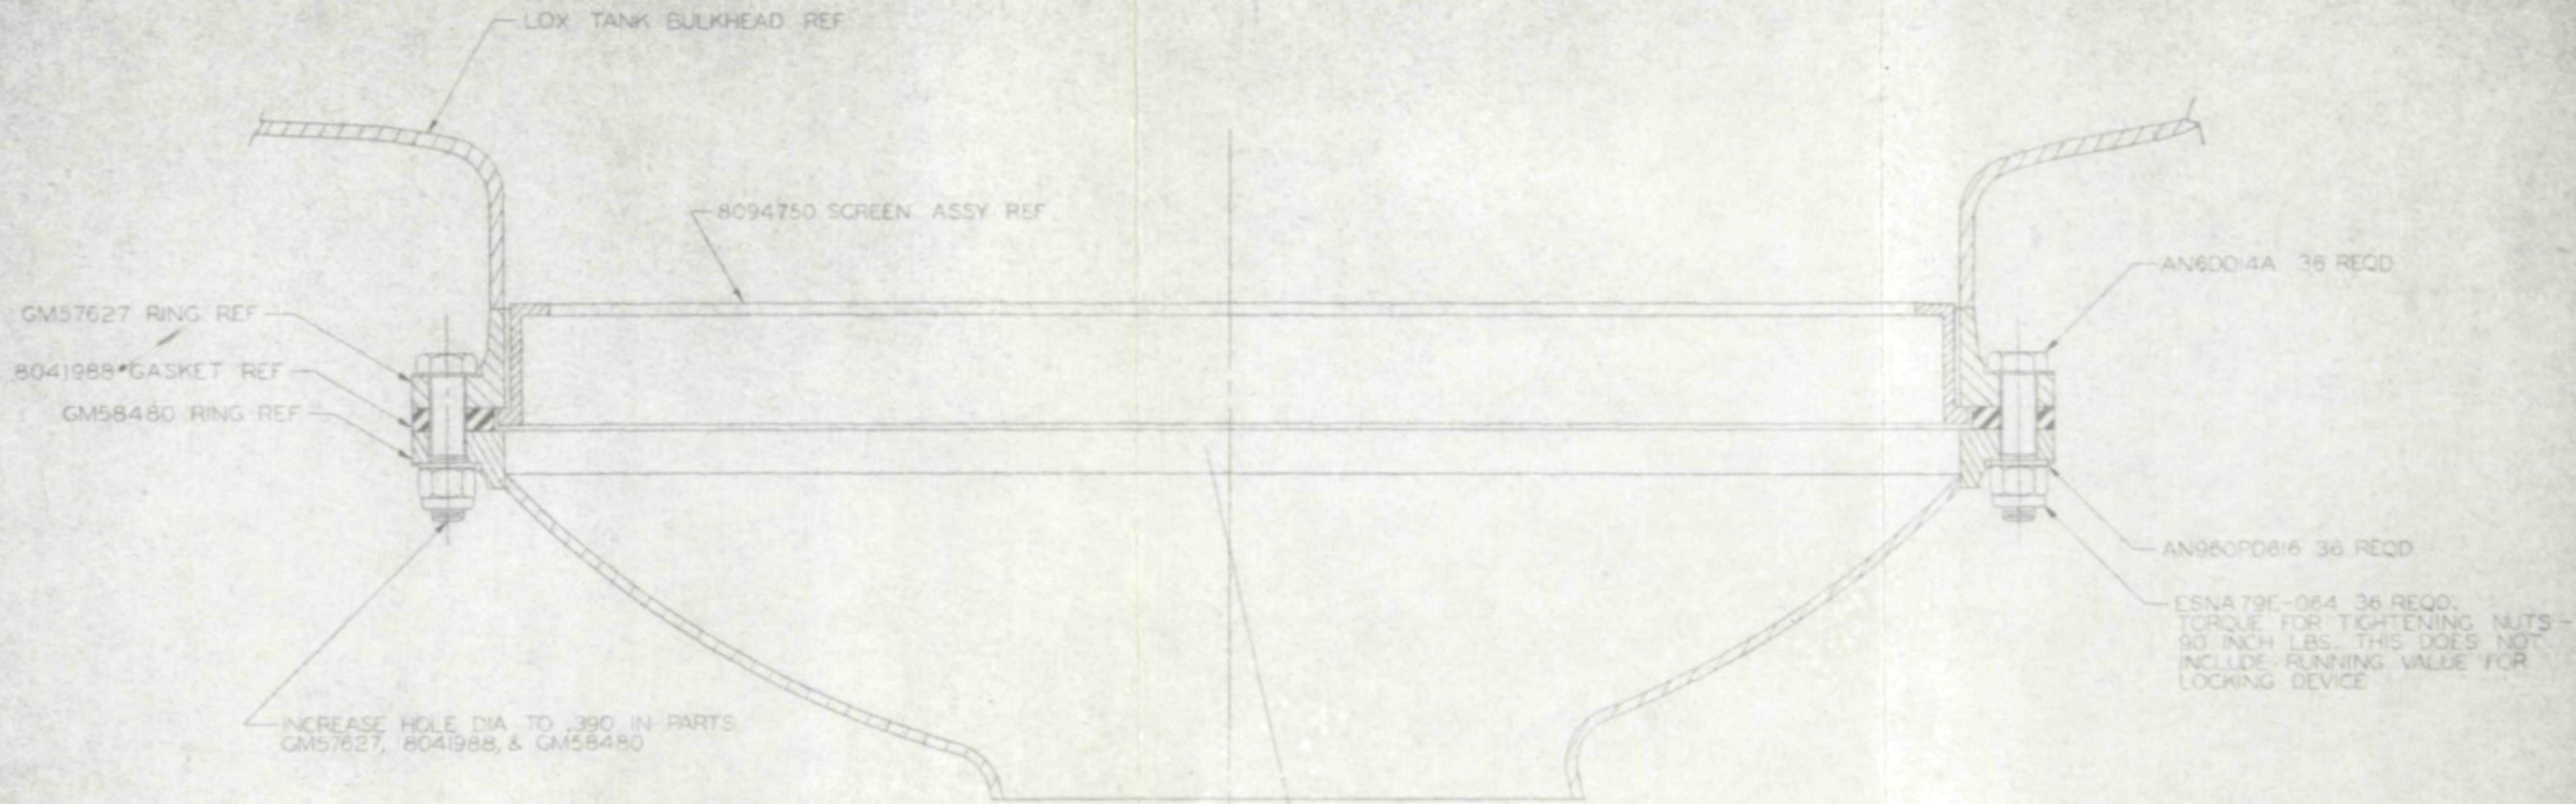
Figure 9.- Lox manhole.

(h) Man-hole LOX leak. - Figure 9 shows the LOX man-hole, gasket, and cover. Some leaking has been experienced on the Mercury-Redstone boosters during tests and on MR-1A while at the Cape. The original bolt torque values were specified to be 90 inch pounds. To correct the leak problem, bolt torques have been raised to 175 inch pounds. This has provided a reliable seal.
