MEMORANDUM ON
X 64 80705 #
Code SA
MERCURY-REDSTONE BOOSTER PROBLEMS

(NASA TM X-54664)

NASA - Space Task Group
Langley Field, Virginia
March 20, 1961

Subject: Mercury-Redstone booster problems

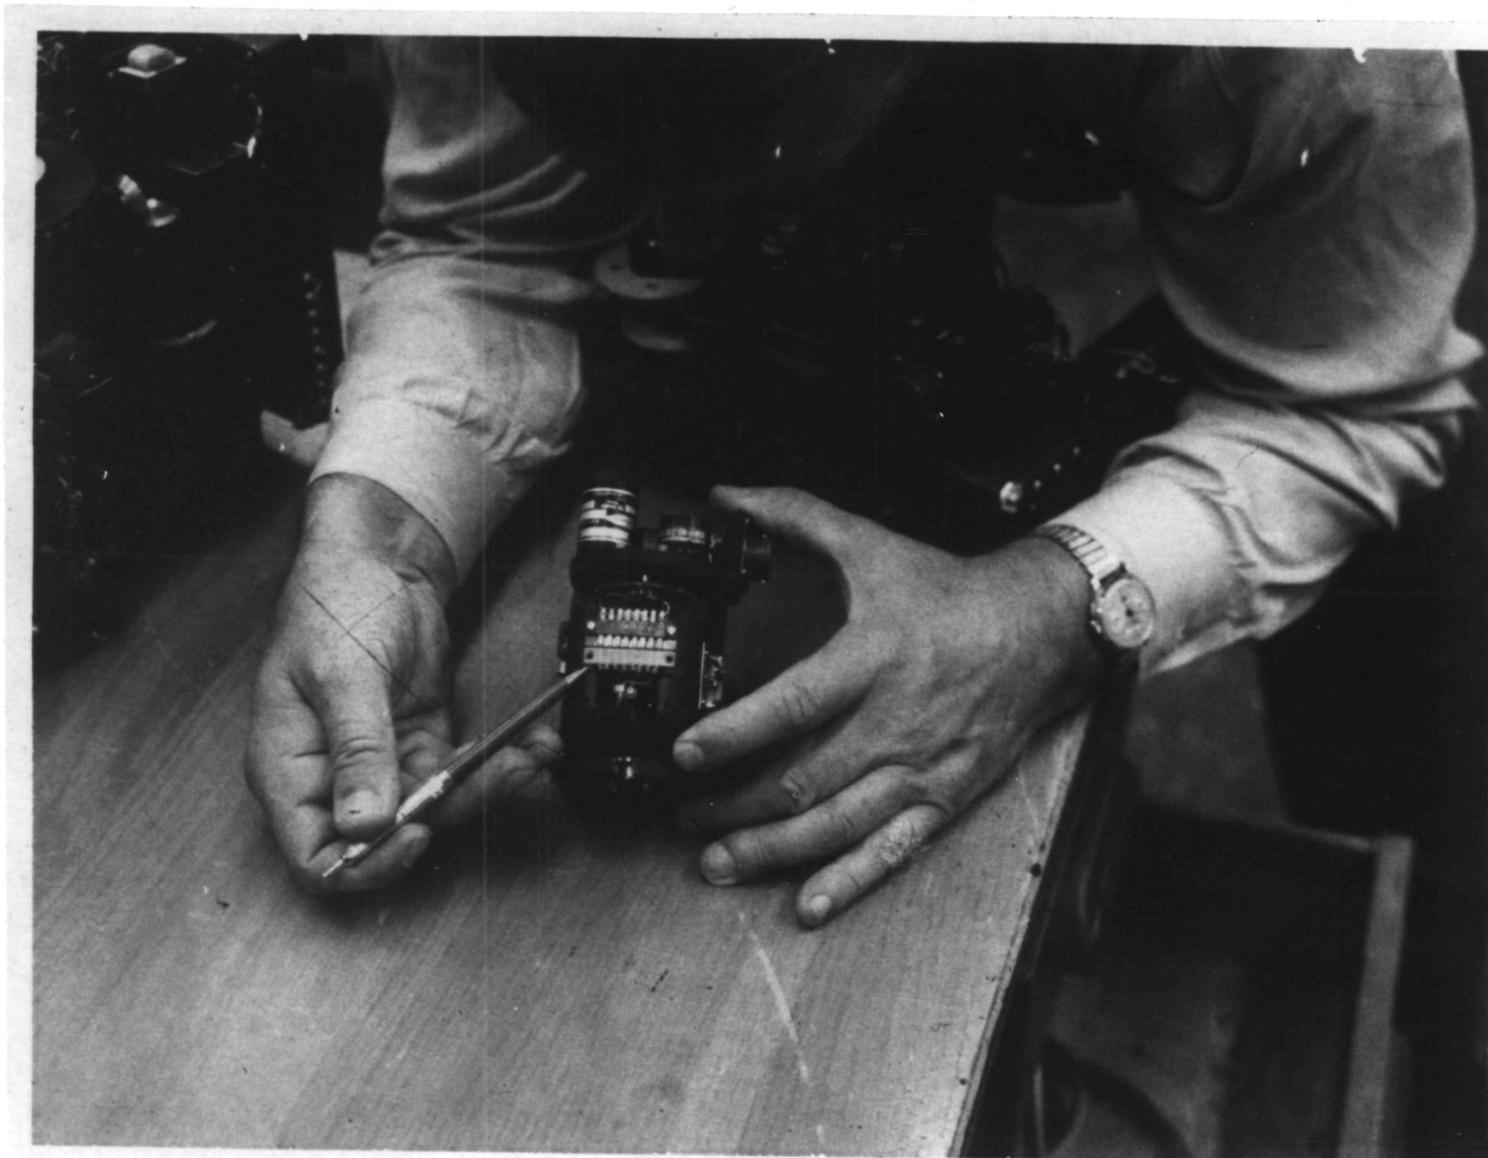
Previous to the change, the gyro assembly had eight wires going to it as the buss bar was mounted to the rotating assembly as shown in figure 10. These wires caused hysteresis at g levels other than 1.0; at $1g$ the torques caused by the wire coils had been compensated for. The new design, shown in figure 11, has the buss bar on the frame so that only three wires (required for the gyro motor operation itself) go to the rotating assembly. These are now light flex wires which offer negligible resistance torque.

Figure 10.- Old design gyro assembly with eight coils.

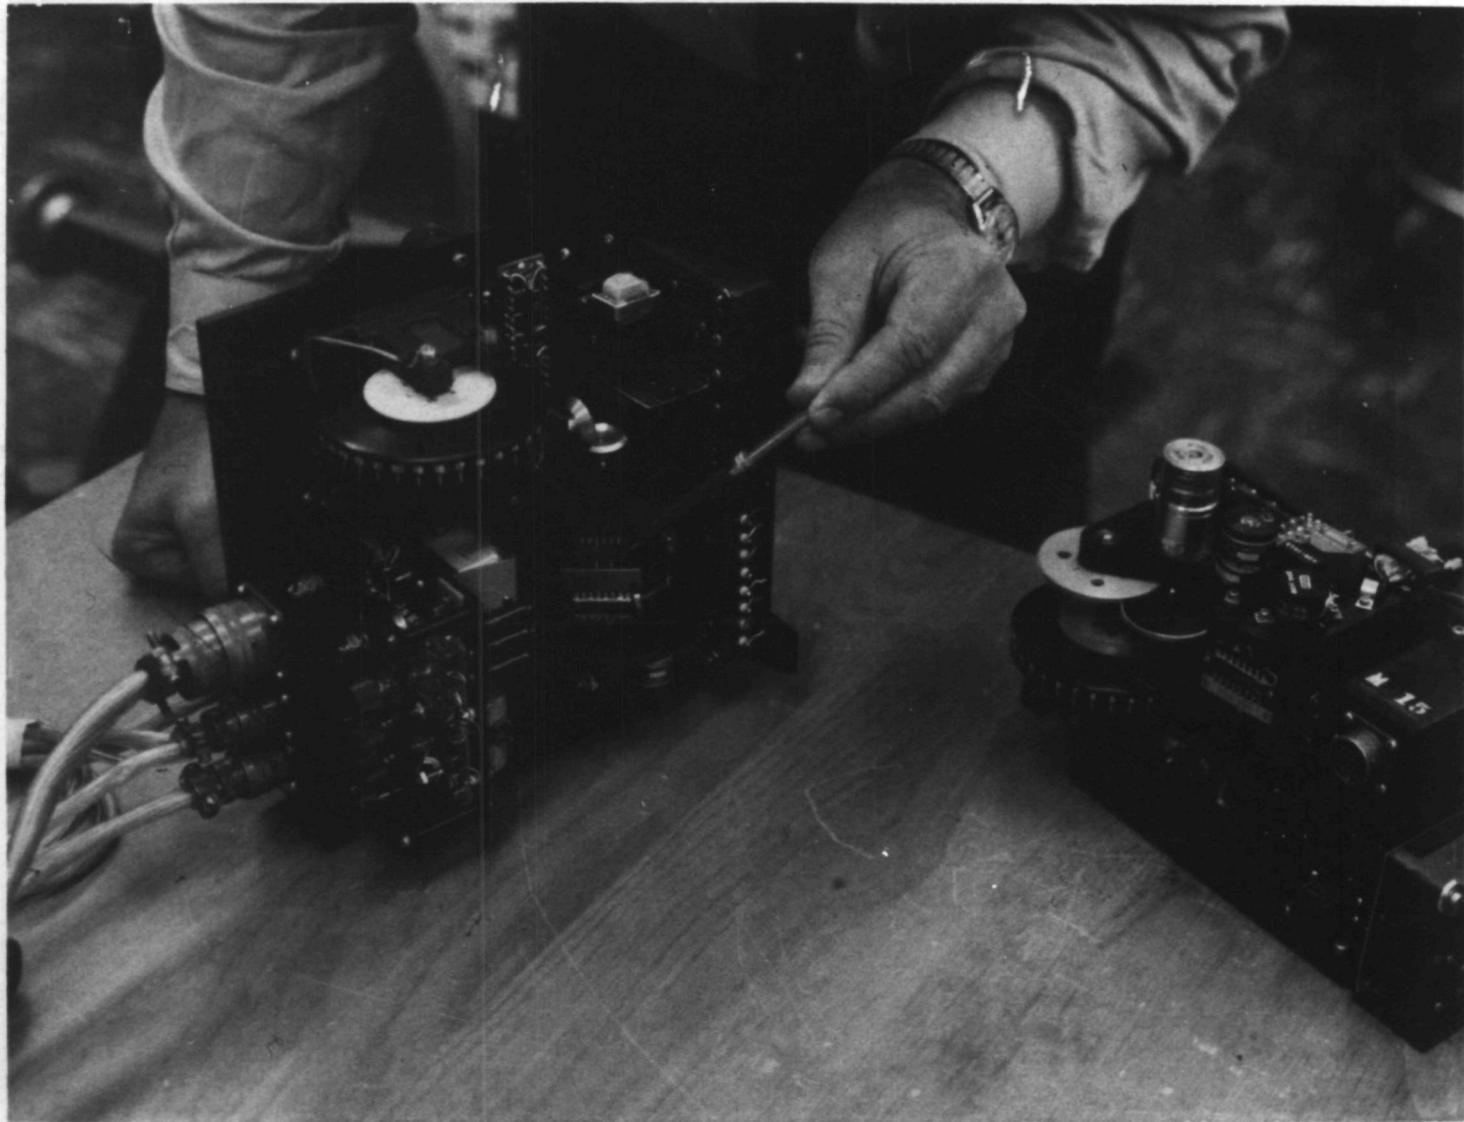
Figure 11.- New design gyro assembly with three flex leads.

The new design has been flown on two Pershing missiles and MR-2. Data obtained on these flights, though not complete in one Pershing and MR-2, indicated satisfactory operation.

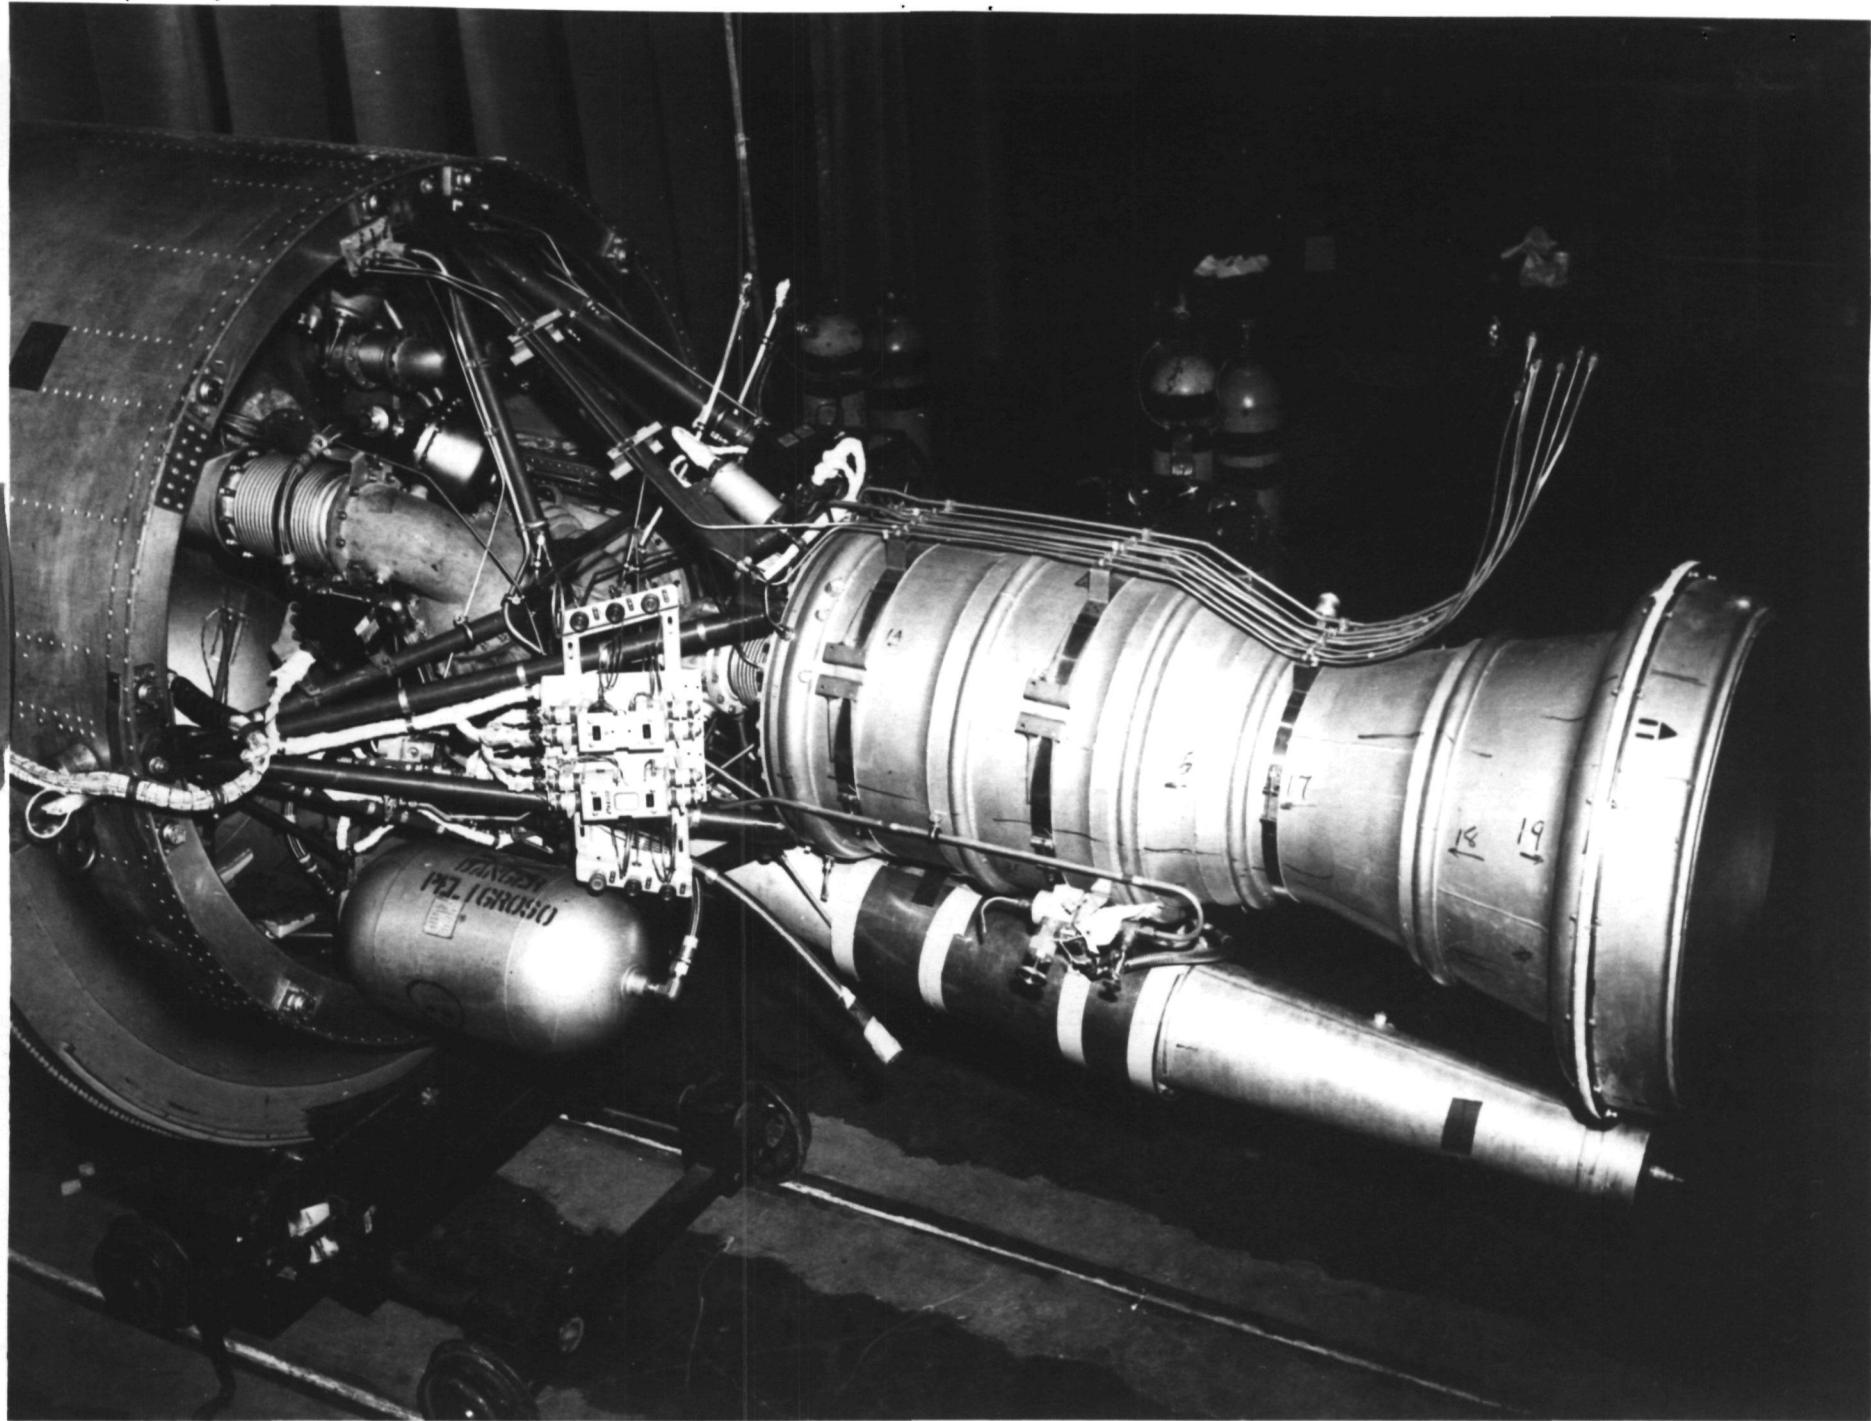
1. General information. - The rocket engine utilized as the power plant of the Mercury-Redstone booster was manufactured by Rocketdyne and is essentially the same as the A-7 engine employed in the latest tactical versions of the Redstone missile. Views of the engine are shown in figures 12 and 13. The main difference in these two engines is the addition of an auxiliary hydrogen peroxide tank of approximately 13 gallons capacity to give approximately 24 seconds additional burning required for the Mercury-Redstone program. This auxiliary tank can be seen in figure 12. The main hydrogen peroxide tank has a capacity of 76 gallons.

Figure 12.- View of A7 engine showing auxiliary H₂O₂ tank.

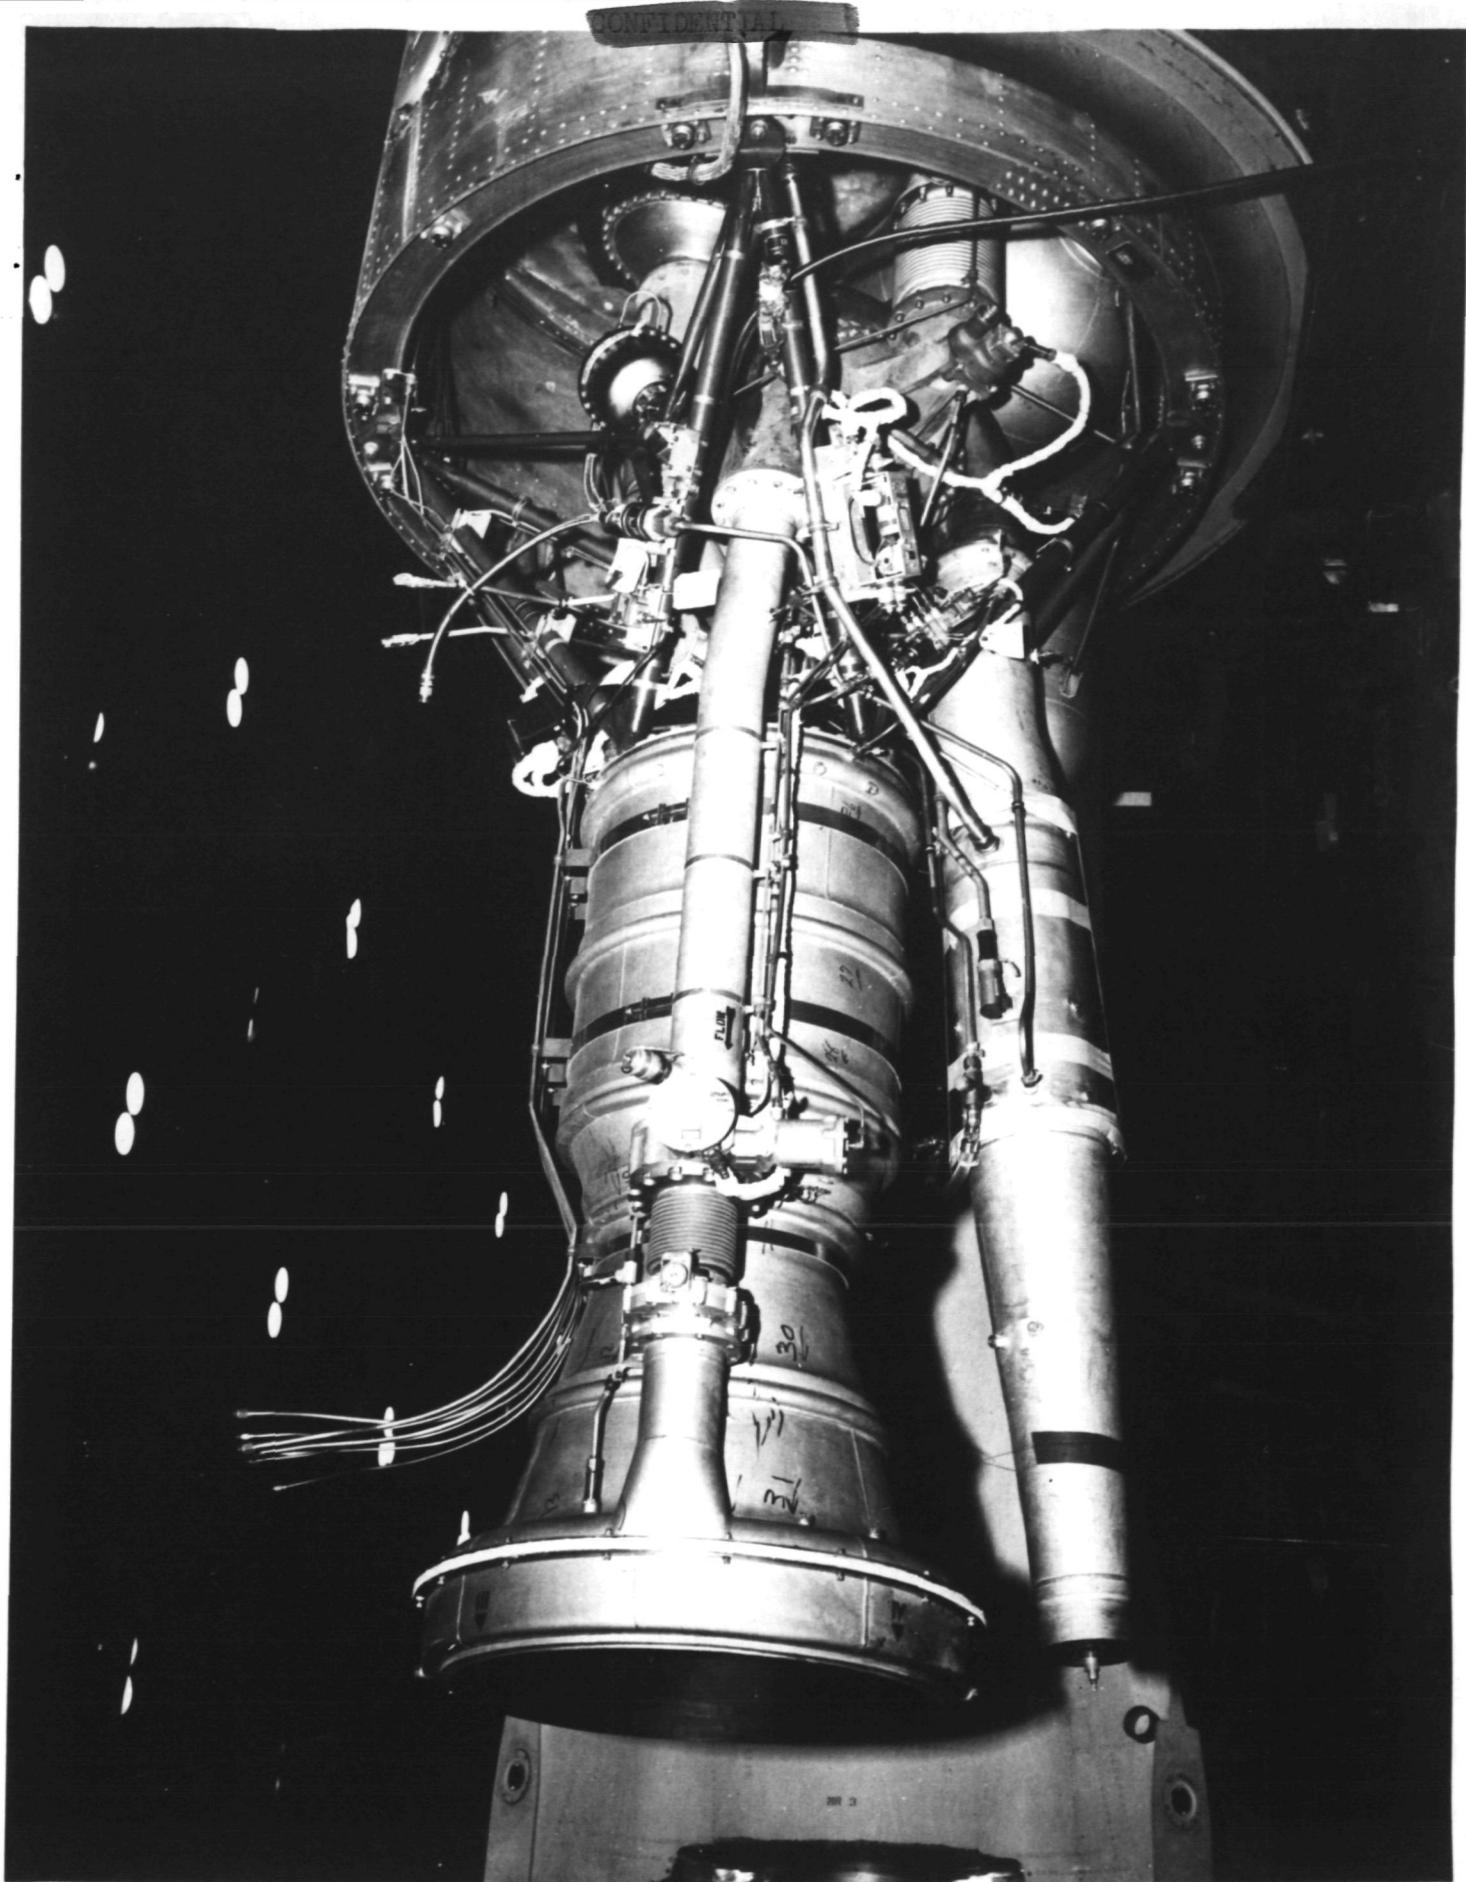
Figure 13- View of A7 Engine showing fuel feed lines.

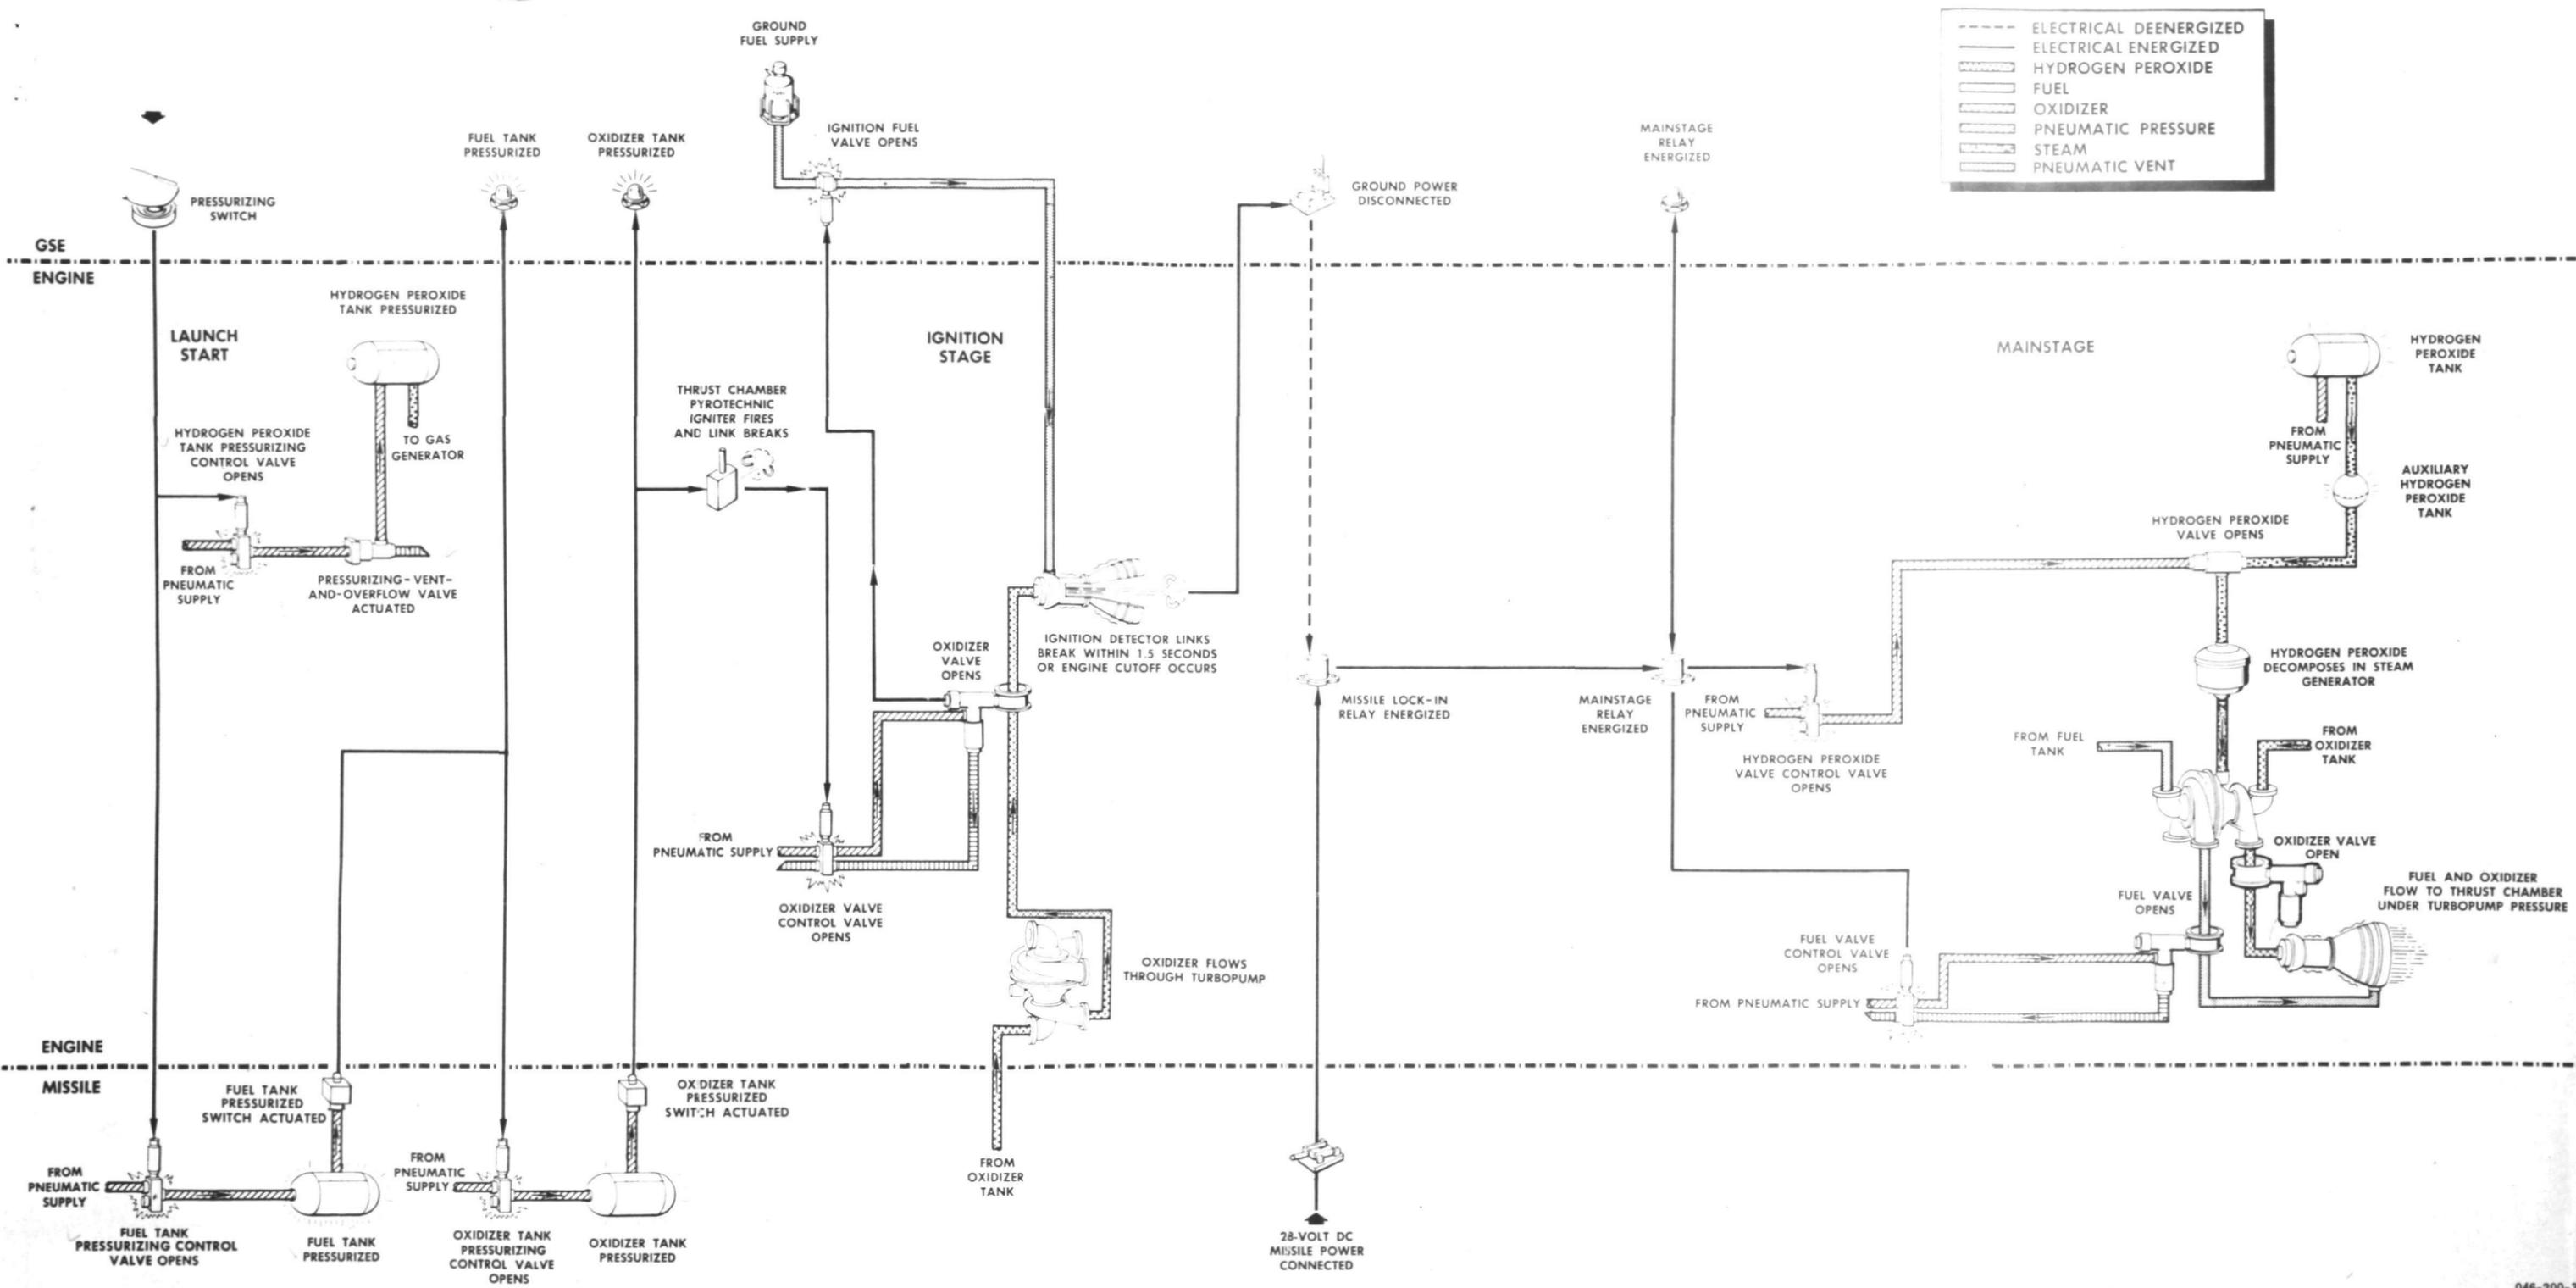
gallons of water to provide an inert liquid load start. When the launch start switch is depressed, the alcohol and the H_2O_2 tanks are pressurized simultaneously. Initial and flight pressurization of these tanks and the control system is provided by seven high pressure gaseous nitrogen spheres. Next, the LOX tank is pressurized. Initial pressurization is from a gaseous nitrogen ground source, flight pressurization is performed by converting liquid oxygen to gaseous oxygen through a heat exchanger. After the correct tank pressures are reached, ignition occurs. At ignition, the thrust chamber pyrotechnic igniter fires, its link breaks, which permits the main LOX valve to open thus allowing LOX to flow to the thrust chamber under combined tank and liquid head pressure. Igniter alcohol is simultaneously directed into the thrust chamber through the center of the injector from the pressurized ground alcohol supply. At this time, LOX rich ignition burning occurs, and the ignition detector link breaks. This energizes the mainstage relay and the hydrogen peroxide valve opens, thus allowing the hydrogen peroxide to pass through the catalyst bed in the steam generator, resulting in steam pressure buildup. The steam is directed to the turbine blades and drives the turbine, which is directly coupled to the liquid oxygen and fuel pumps. The turbopump accelerates and pressure is built up in the fuel line until it is greater than the ground alcohol igniter supply pressure. At about this time the fuel valve opens, allowing the water lead and alcohol to flow into the combustion chamber and initiate mainstage thrust chamber combustion. Figures 15 and 16 show engine schematics from which the above operation description can be followed.

Figure 14.- Launch, Ignition, and Mainstage Combustion Schematic.

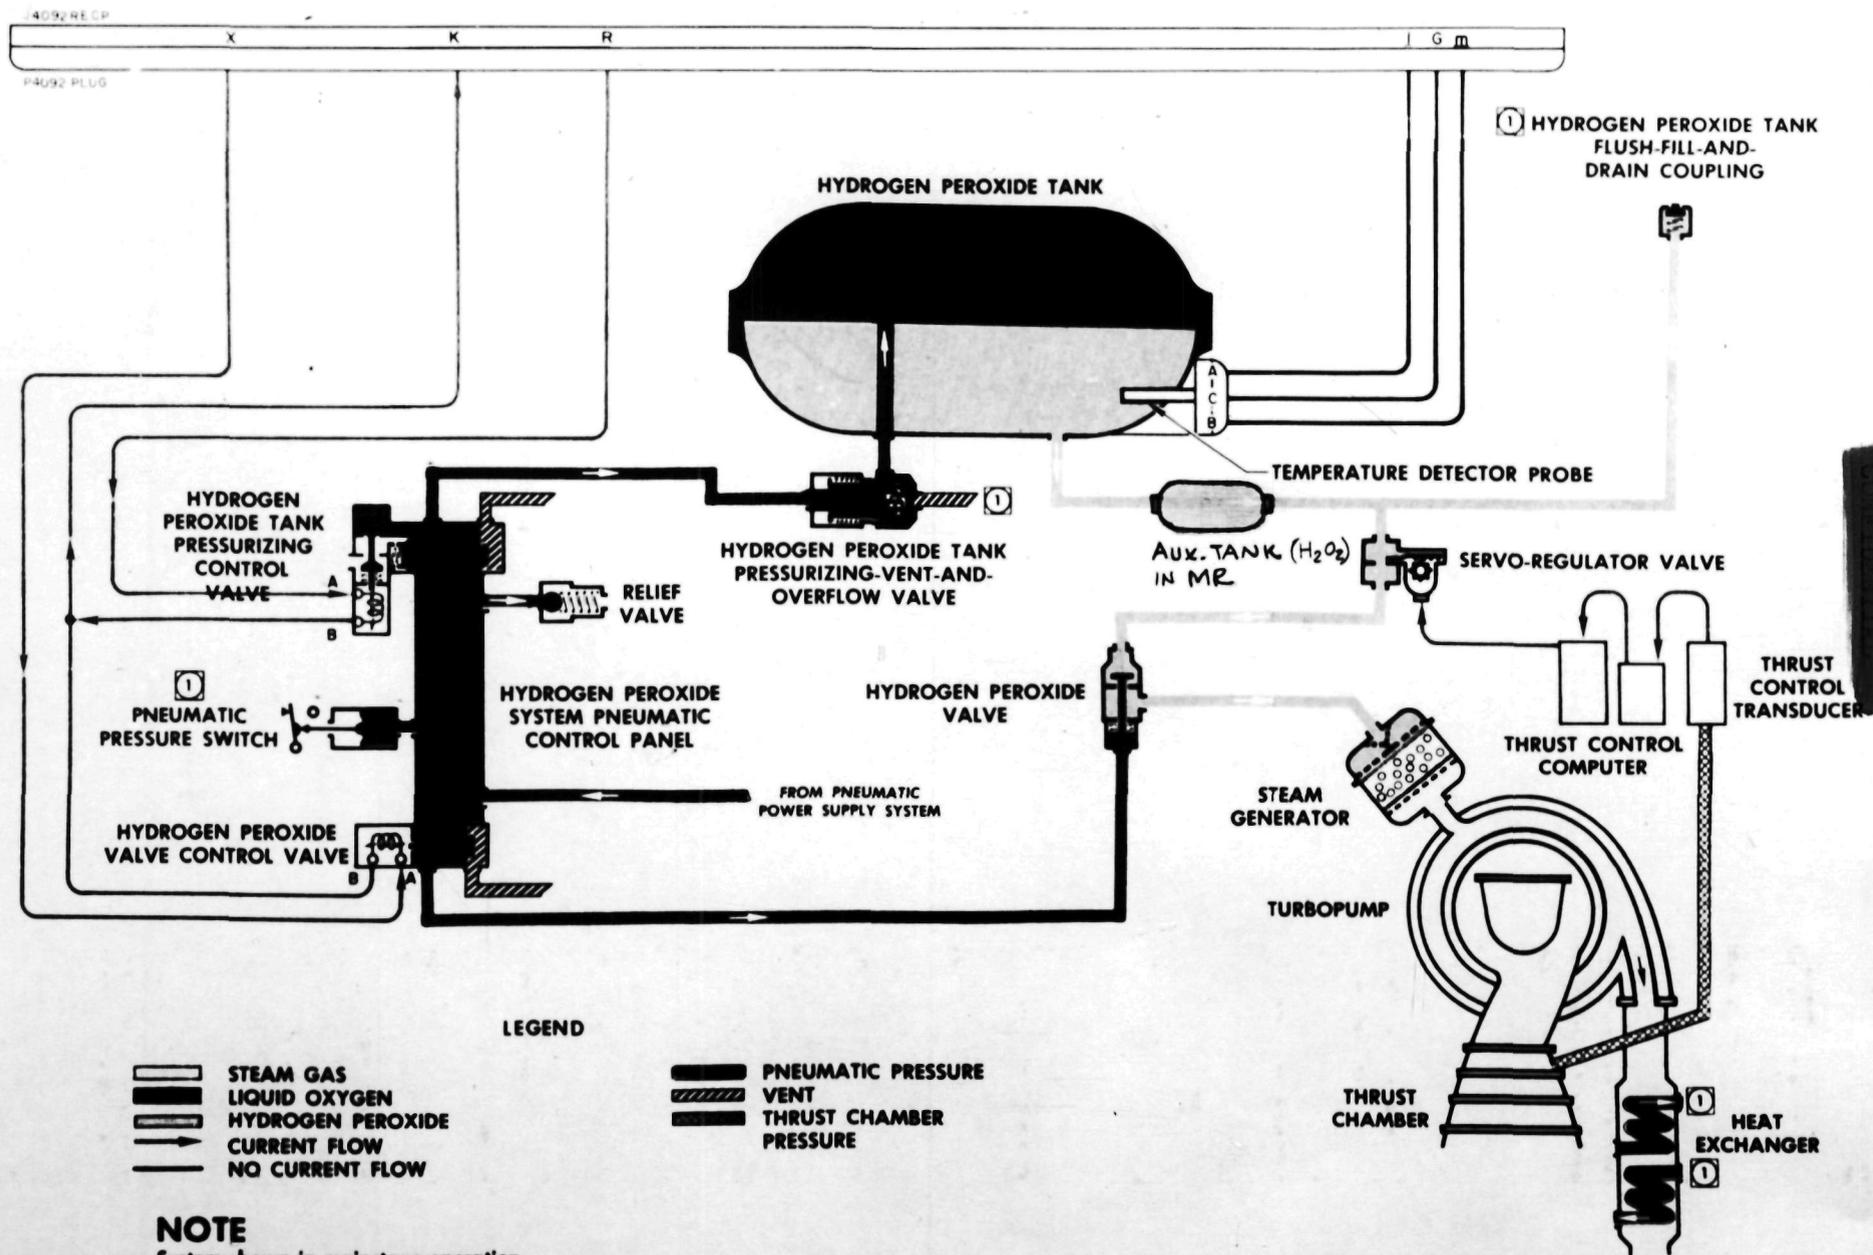
generator system is that part of the engine which develops steam pressure for turbine operation. A mixture of steam and oxygen is produced by the decomposition of 75 percent hydrogen peroxide in the presence of a catalyst, which is made from porous ceramic stones impregnated with potassium permanganate. The resultant steam flow, at approximately 740°F and 385 psi, provides the power for turbopump operation and then flows through a pneumatic and LOX heat exchanger and exhaust duct. Steam generator output is regulated by a servo valve in the hydrogen peroxide line. This assures correct flow conditions to maintain a constant thrust chamber pressure level.

Figure 16.- Schematic showing steam generation.
